## **Dam Inspection Report**

### **Pefferlaw Dam**

**D.M. Wills Project Number 19-5381**

**Prepared for:  
Lake Simcoe Region  
Conservation Authority**

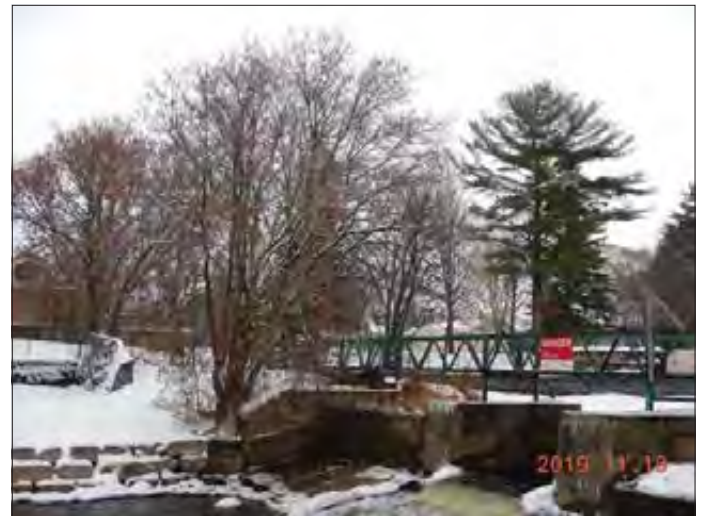
Photo 2701 - Sept 19, 2019  
Pefferlaw Dam  
Large Tree on Crest of Left (West) Earth Embankment

There are a number of large trees growing on the embankment and immediately adjacent to the concrete structures. The root systems from these trees have the potential to cause damage to the concrete sections of the dam and encourage piping through the earth sections of the dam. Additionally, if one of the large trees were to fall and pull up the root ball, the ability of the earth embankment to retain the head pond may be compromised.

Recommendation	Description of Deficiency	Priority	Estimated Cost	Additional Comments
1. Remove the trees from the earth embankment and from adjacent to concrete or masonry structures and remediate the voids left by the root systems.	There are a significant number of large trees located on the earth embankment sections.	Medium	\$15,000	The cost estimate assumes that a contractor would be hired to remove the trees, remediate the root systems and restore the earth embankment. Cost savings may be realized if the LSRCA is able to complete this work using internal resources.

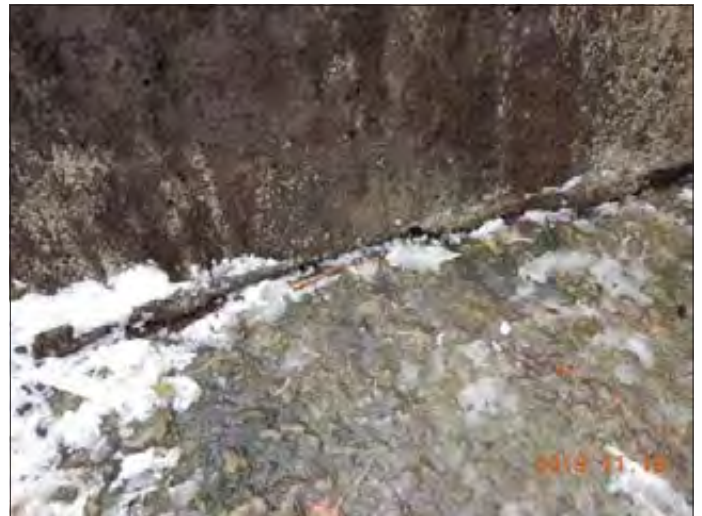
Photo 2760 - Sept 19, 2019  
Pefferlaw Dam

Gap Between Left (West) Weir and Left (West) Apron

**Left (West) Weir** – Inspection of the left (west) weir was limited as it was partially snow covered during the inspection. There is a large gap (25 mm) at the construction joint where the flat section of the weir crest meets the sloping section of the weir crest. There is also a wide crack located approximately 200 mm downstream of the construction joint. There is a 600 mm wide strip along the sloping section of the weir that is delaminated in the area that was exposed by Wills' snow removal. The flat section of the weir crest contains a number of square holes for the installation of the flashboard posts. There appears to be a construction joint approximately 60 mm below the downstream weir crest on the downstream face of the weir. The downstream face of the weir is in good condition, however, there is a 30 mm gap at the interface of the weir and the apron. Video from the underwater inspection did not identify any undercutting of the upstream side of the weir.

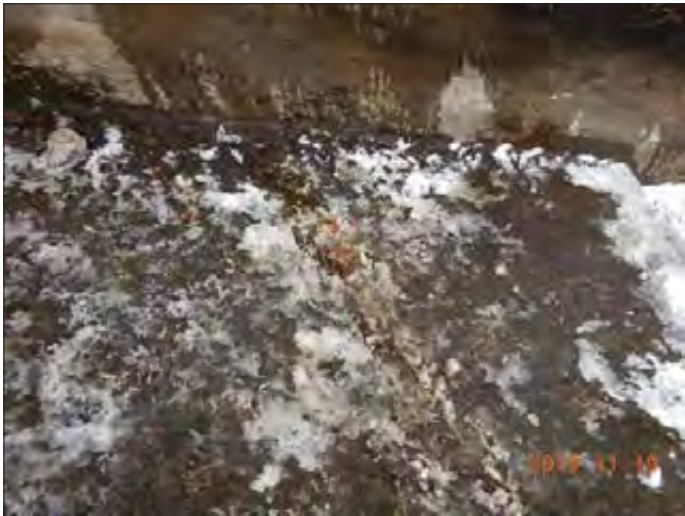
Photo 2762 - Sept 19, 2019  
Pefferlaw Dam

Crack in Left (West) Apron at Downstream End

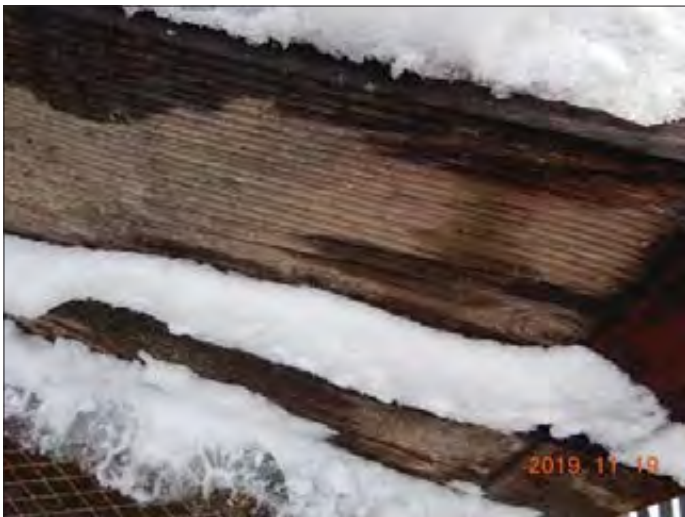
Photo 2798 - Sept 19, 2019  
Pefferlaw Dam

Stoplog Condition

Recommendation	Description of Deficiency	Priority	Estimated Cost	Additional Comments
5. Replace the flashboards and flashboard posts, as planned. Note: Future replacement of the stoplogs may be required.	The flashboards and flashboard posts are in poor condition and the LSRCA is already planning to replace them. The stoplogs may require replacement in 2 to 5 years.	High	\$8,000	The cost estimate assumes that the LSRCA will outsource the fabrication of the flashboard posts and will fabricate the flashboards using internal resources.

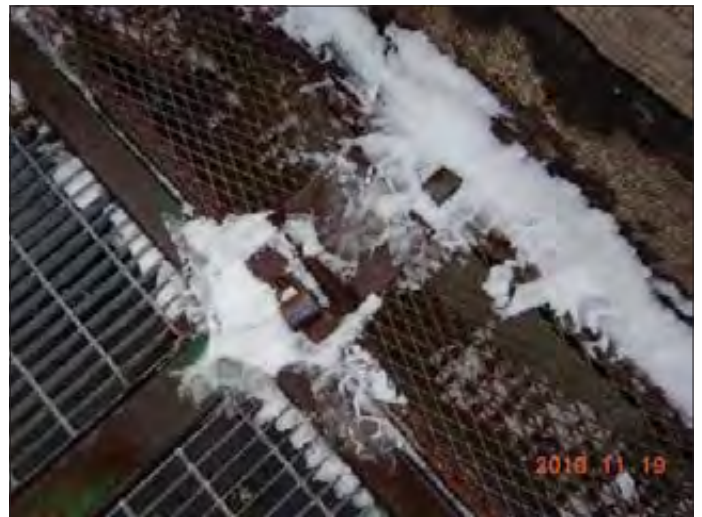
Photo 2799 - Sept 19, 2019  
Pefferlaw Dam

Stoplog Condition

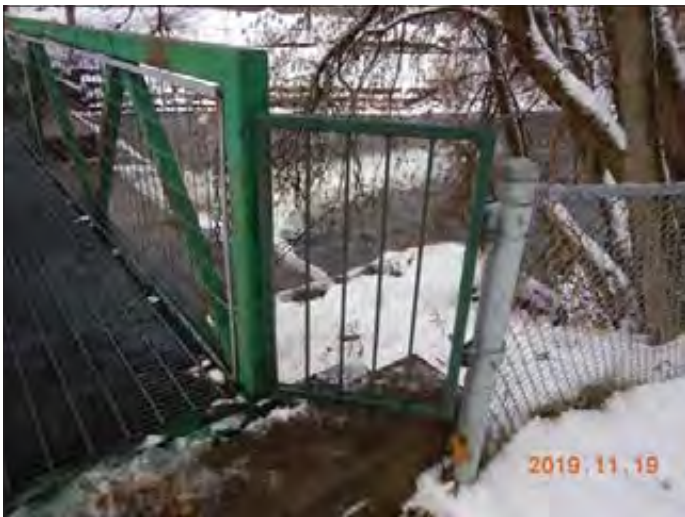
Photo 3916 - Sept 19, 2019  
Pefferlaw Dam

Cracks in Vertical HSS Sections of the Truss Bridge

3. Undertake a structural evaluation of the truss bridge within one (1) year and develop a detailed repair or replacement design for the truss bridge and dam deck. Depending on the results of the structural evaluation, temporary repairs, the removal of the stoplogs stored on the deck or temporary suspension of dam operations may be required.	The steel truss is in poor condition with failure of the coating and cracking and bowing of the structural steel members.	Immediate	\$5,000*	The cost estimate provided is the cost for the structural evaluation only. The cost for the detailed design for the repair or replacement will depend on the results of the structural evaluation and on the structure type but would likely be in the range of \$30,000 to \$60,000.  This work should be completed by a professional consulting engineer.  As an alternate to undertaking Recommendation 3, the LSRCA could stop operating the dam, remove the stoplogs stored on the dam and eliminate public access across the dam. However, this is only seen as a short term solution and a permanent solution, such as repair, replacement or dam decommissioning will ultimately be required in order to ensure public and operator safety.

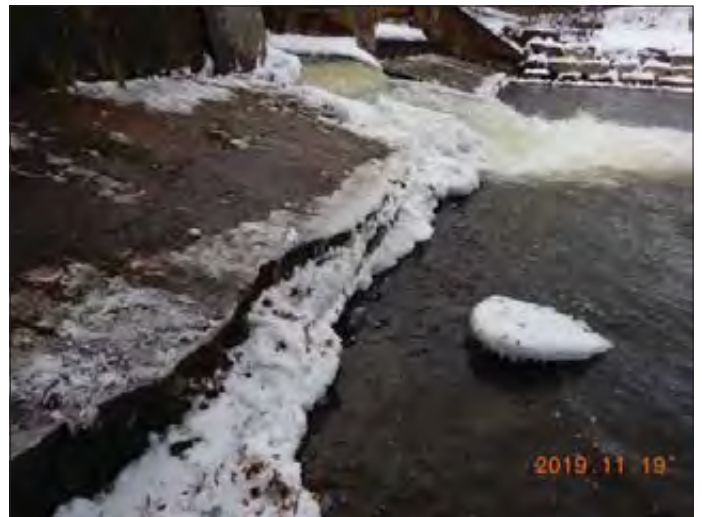
Photo 2851 - Sept 19, 2019  
Pefferlaw Dam

Undercutting in Right (East) Apron

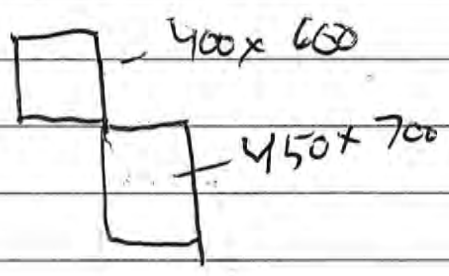
to exposed  
re-inforcing  
large, round aggregate  
cast spall 600x250

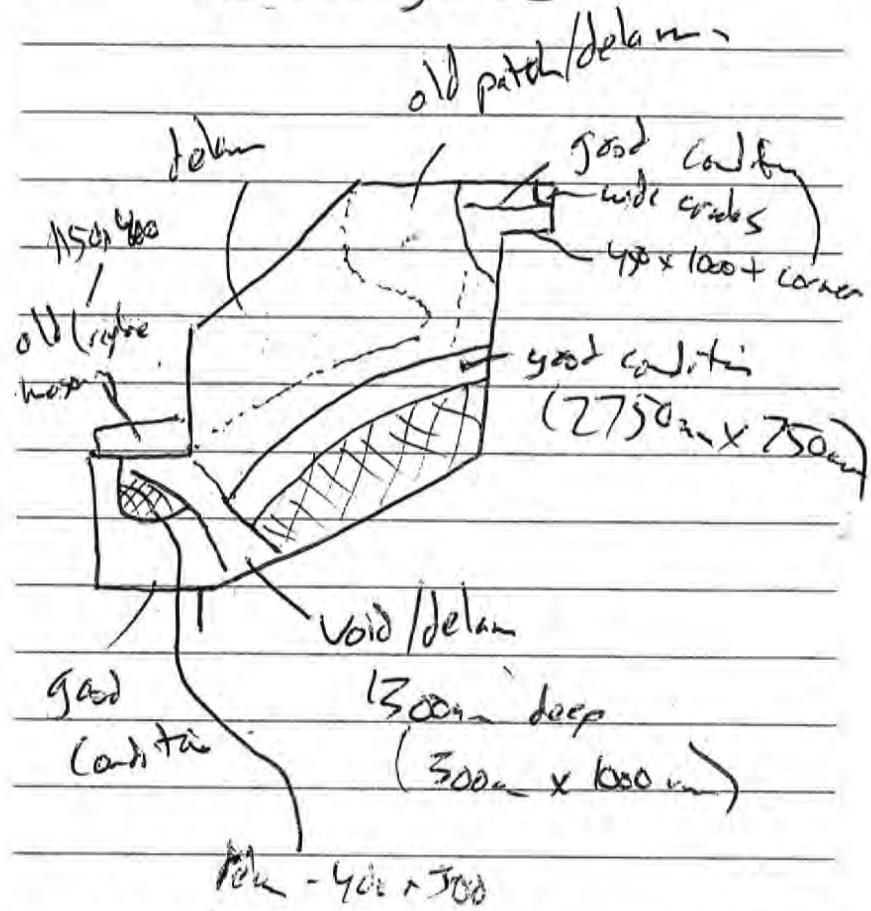
Project: East Wing

Notes: large, round exposed aggregate.  
Past patch repair.
