## **Dam Inspection Report**

### **Pefferlaw Dam**

**D.M. Wills Project Number 19-5381**

**Prepared for:  
Lake Simcoe Region  
Conservation Authority**

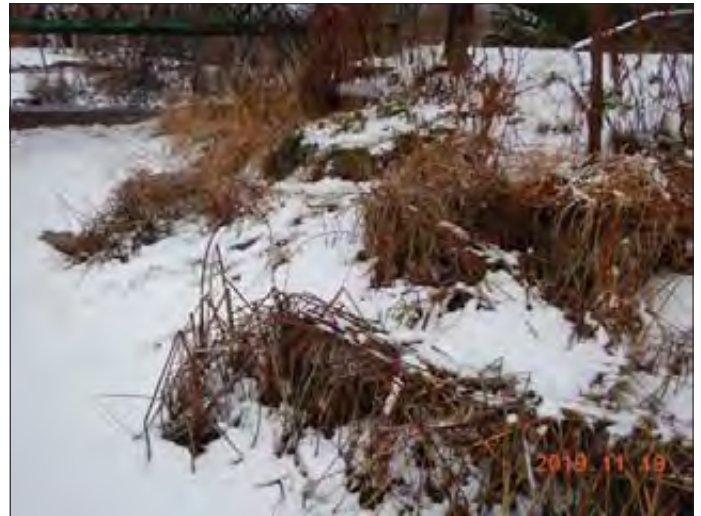
WILLS WILSON CONSULTANTS  
Lake Simcoe Region Conservation Authority  
Photo 2671 - Sept 19, 2019  
Pefferlaw Dam  
Upstream Right Earth Embankment

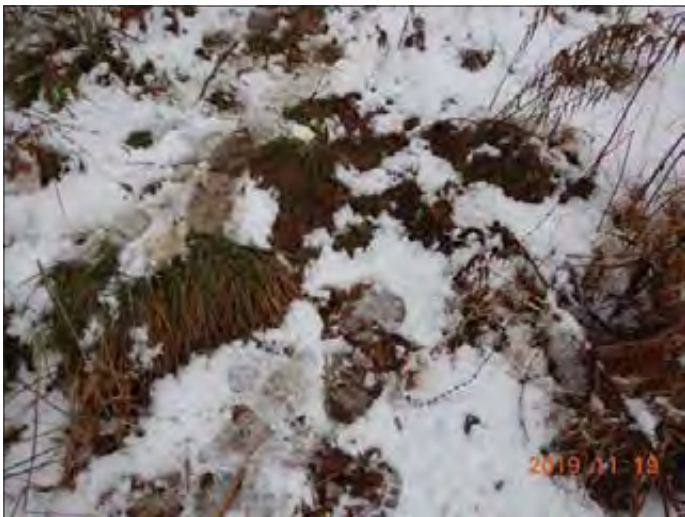
WILLS WILSON CONSULTANTS  
Lake Simcoe Region Conservation Authority  
Photo 2674 - Sept 19, 2019  
Pefferlaw Dam  
Upstream Right Earth Embankment

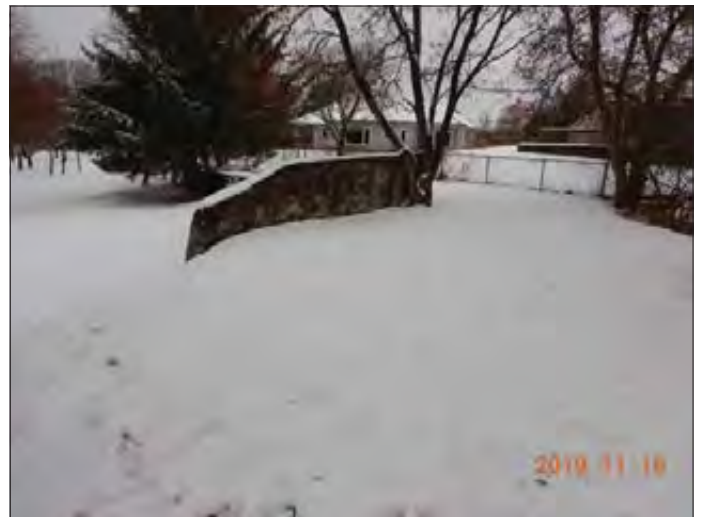
WILLS WILSON CONSULTANTS  
Lake Simcoe Region Conservation Authority  
Photo 2676 - Sept 19, 2019  
Pefferlaw Dam  
Right Earth Embankment Crest

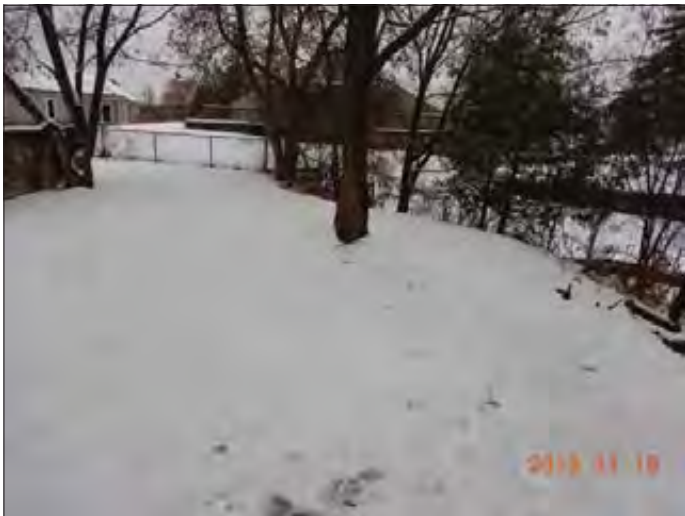
WILLS WILSON CONSULTANTS  
Lake Simcoe Region Conservation Authority  
Photo 2677 - Sept 19, 2019  
Pefferlaw Dam  
Right Earth Embankment Crest

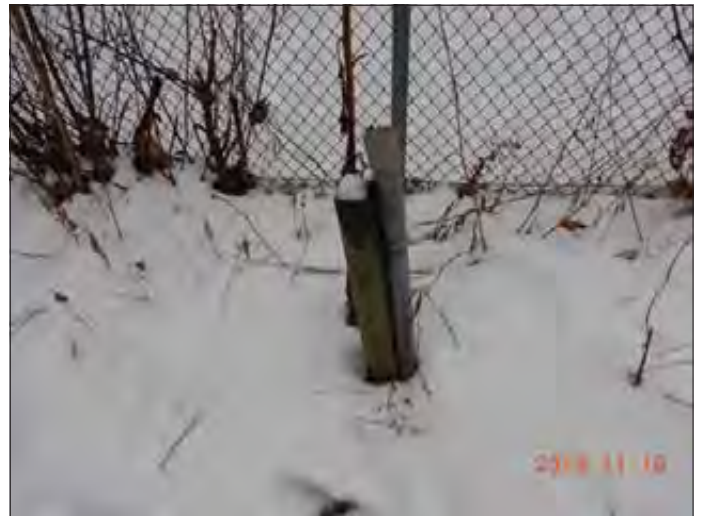
WILLS WILSON CONSULTANTS  
Lake Simcoe Region Conservation Authority  
Photo 2682 - Sept 19, 2019  
Pefferlaw Dam  
Monitoring Well on East Side of Park

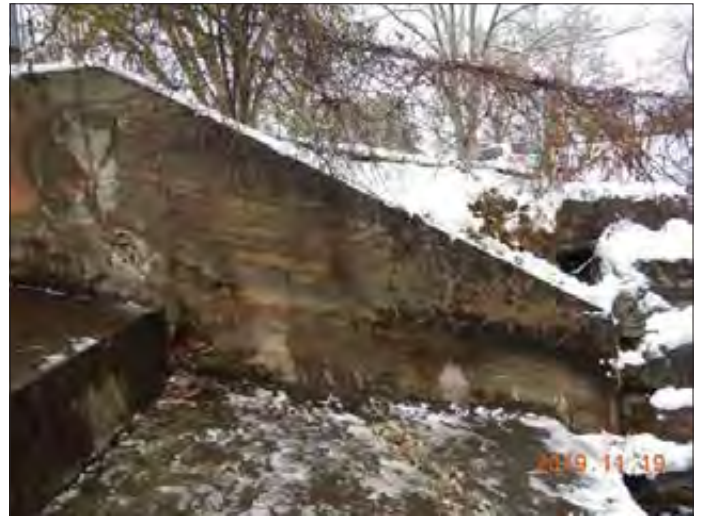
Photo 2763 - Sept 19, 2019  
Pefferlaw Dam

Left (West) Dam Abutment

**Left (West) Dam Abutment** – The left (west) dam abutment is generally in fair to poor condition. There is a large spall measuring approximately 500 mm by 400 mm by 200 mm deep at the interface of the upstream face of the left (west) weir and the left

(west) abutment. There are a number of smaller spalls near the base of the wall at the winter water level. There is some delaminated concrete near the flashboard gain.

There is a wide crack at a construction joint that extends across the height of the wall extending from the interface with the left (west) weir to the top of the wall. There are two large spalls above the downstream crest of the weir along the wide crack measuring approximately 400 mm by 600 mm (exposed and corroded steel reinforcing, large round aggregate) and 450 mm by 700 mm. There is another spall at the base of the abutment (where it meets the apron) that measures approximately 600 mm by 200 mm.

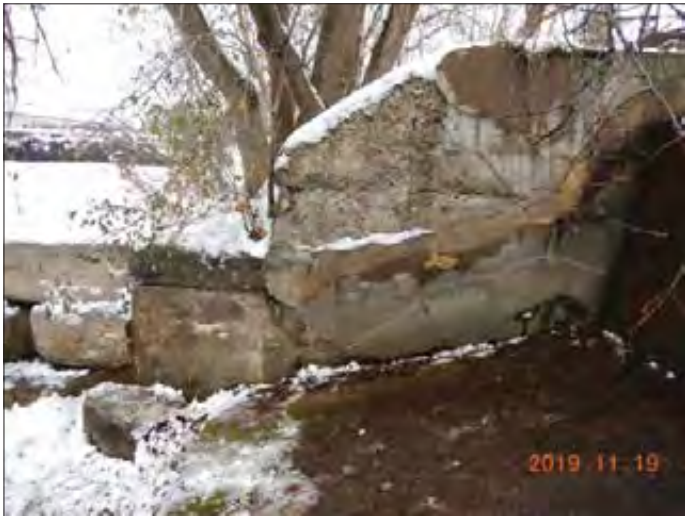
WILLS WATERSHED  
Lake Simcoe Region Conservation Authority  
Photo 2836 - Sept 19, 2019  
Pefferlaw Dam  
Right (East) Dam Abutment

**Right (East) Dam Abutment** – The right (east) abutment is in poor to very poor condition. There is evidence of patch repairs at this wall area. The majority of the wall surface is delaminated and there are several large spalls. There is some map cracking with efflorescence at the far downstream end of the wall, with a 300 mm by 1000 mm by 300 mm deep void. There is a masonry wall perched on the downstream edge of the right (east) abutment that is in very poor condition.

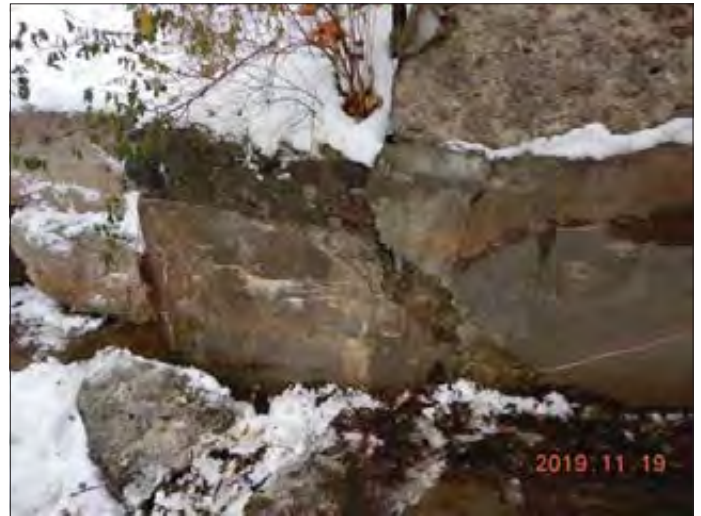
WILLS WATERSHED  
Lake Simcoe Region Conservation Authority  
Photo 2838 - Sept 19, 2019  
Pefferlaw Dam  
Right (East) Dam Abutment

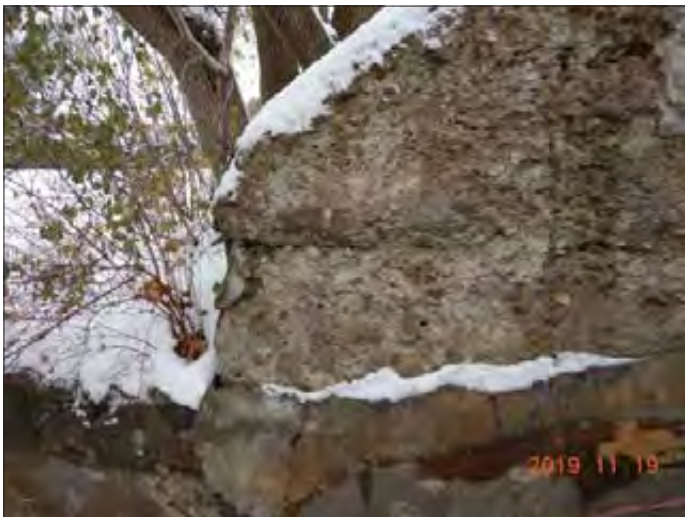
WILLS WATERSHED  
Lake Simcoe Region Conservation Authority  
Photo 2839 - Sept 19, 2019  
Pefferlaw Dam  
Right (East) Dam Abutment

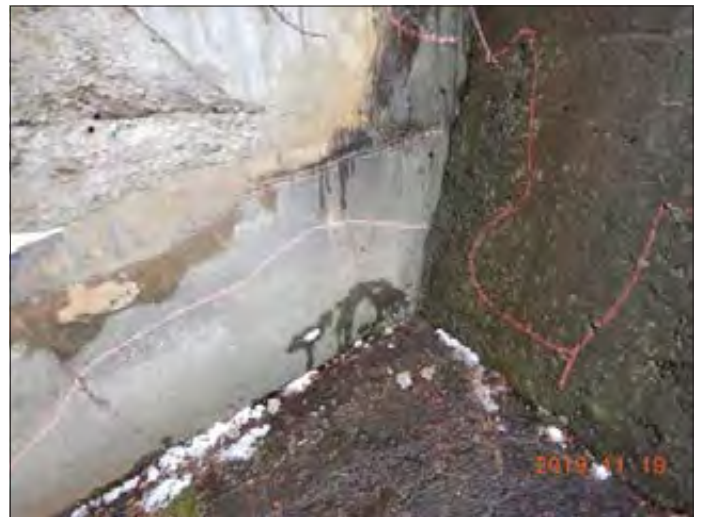
WILLS WATERSHED  
Lake Simcoe Region Conservation Authority  
Photo 2840 - Sept 19, 2019  
Pefferlaw Dam  
Right (East) Dam Abutment

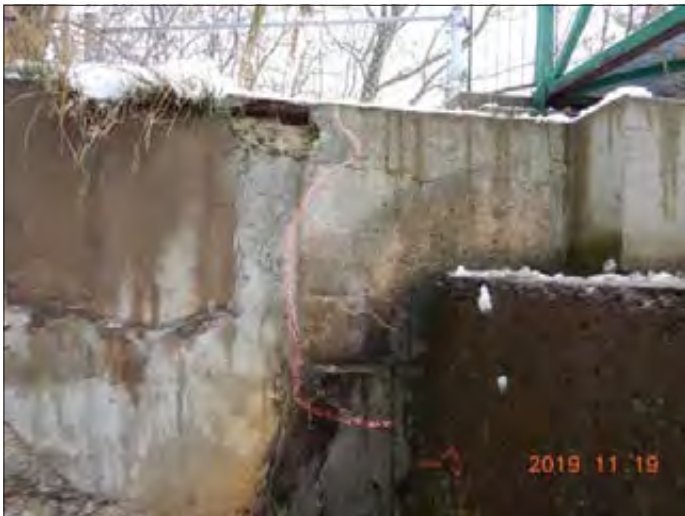
WILLS WATERSHED  
Lake Simcoe Region Conservation Authority  
Photo 2841 - Sept 19, 2019  
Pefferlaw Dam  
Right (East) Dam Abutment

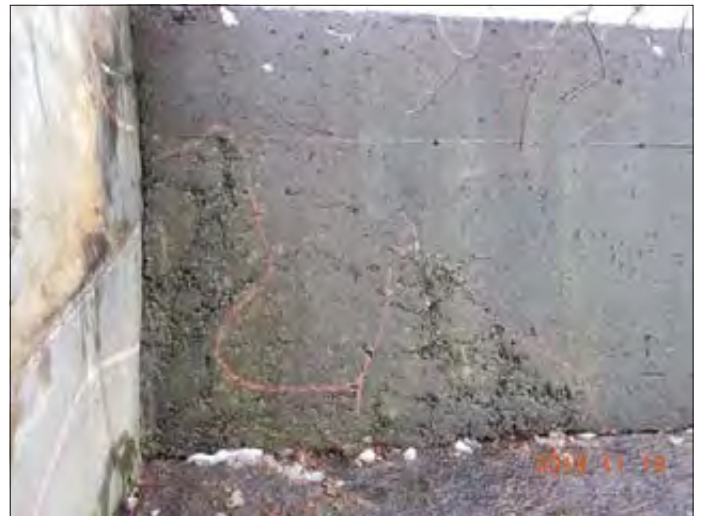
WILLS WATERSHED  
Lake Simcoe Region Conservation Authority  
Photo 2842 - Sept 19, 2019  
Pefferlaw Dam  
Downstream Side of Right (East) Weir

**Right (East) Weir** – The upstream face of the weir is generally in good condition with some bug holes. The weir crest is in good condition. The downstream face of the weir is in fair to good condition with honeycombing noted near the interface with the abutment (1.2 m<sup>2</sup>).
