Retrofitting of Urban Stormwater Management Facilities in the Lake Simcoe Watershed Using Innovative Technologies:

Comparison of Three Innovative Solutions

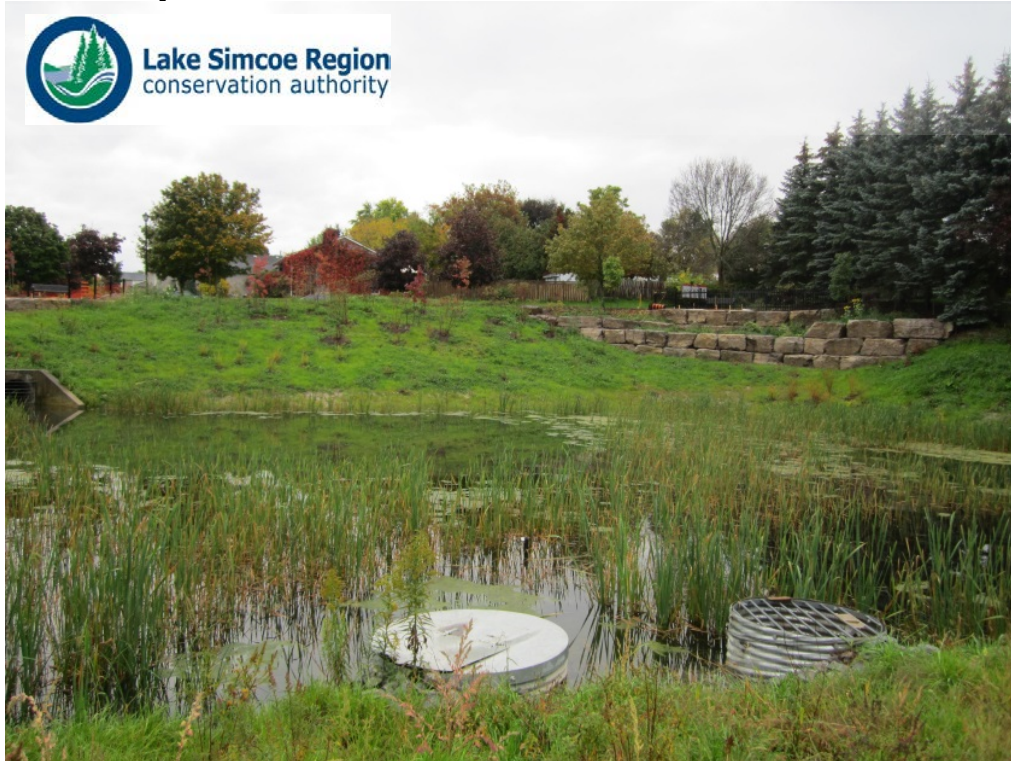
Post Construction of Stormwater Management Pond Retrofit at Colony Trail, East Gwillimbury

Retrofit 2: The design for the Colony Trail stormwater management retrofit project in East Gwillimbury included a typical forebay with the installation of several wetland cells and a “sorbative” media chamber. The treatment train approach is similar to the above noted project with the “sorbative” media chamber being the last stop to capture the soluble phosphorus prior to entering the receiving waters. This project included a mixture of using natural plant life in the wetland cells and innovative media materials to improve water quality.

The Colony Trail stormwater management retrofit project has a catchment area of 19.3 hectares with an anticipated phosphorus reduction of 25 kg/year.

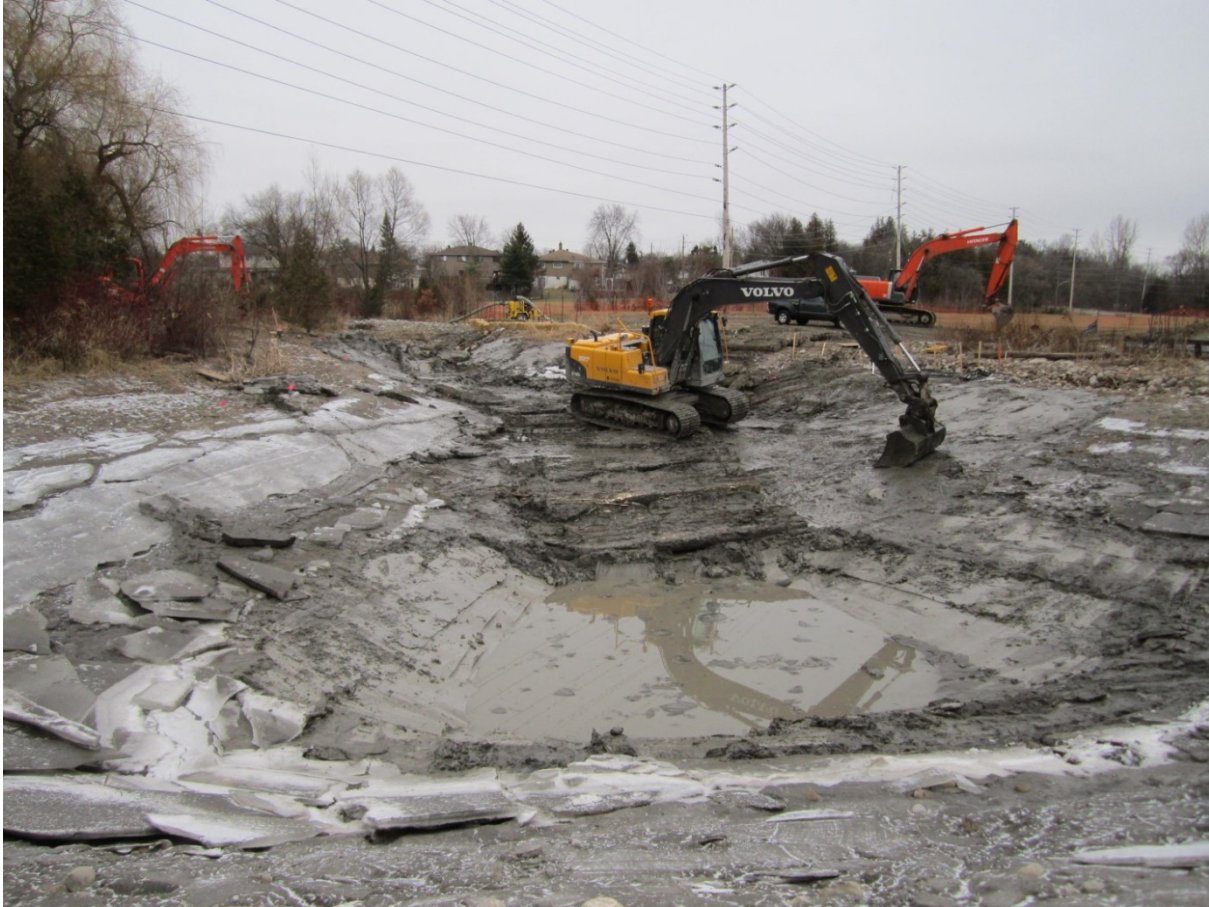
Dewatering and Excavation of Forebay at George Richardson site

Retrofit 1: The design for the George Richardson stormwater management retrofit project in Newmarket included a typical forebay and main cell with the installation of an oil/grit separator and a red sand filter media chamber. The treatment train approach is intended to first capture the larger sediment particles and then the suspended particles and soluble material as the water travels through the system. The red sand filter media chamber is designed to capture the soluble phosphorus that generally passes through a typical stormwater management pond. Considerably level existing grades were one of the issues at this site. The original concept design looked at installing a pumping system to assist in conveying flows through the treatment train. Due to the potential costs and maintenance issues, the solution was to extend the outfall pipe to create enough elevation for the system to function on gravity alone.

The George Richardson stormwater management retrofit project has a catchment area of 155.0 hectares with an anticipated phosphorus reduction of 23 kg/year.

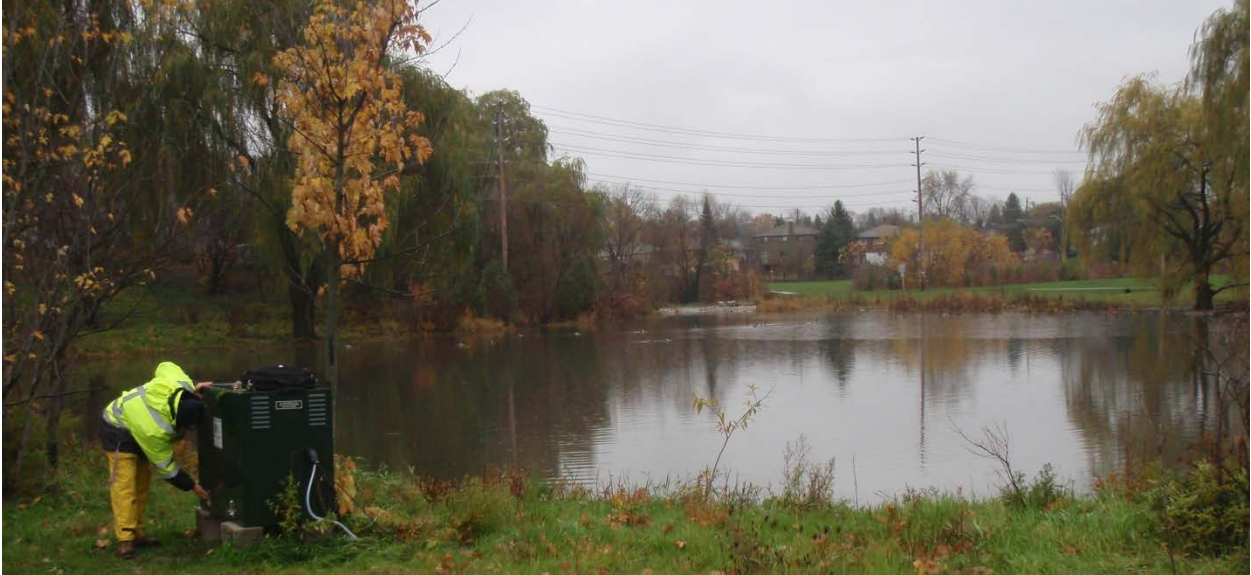
Autosampler at George Richardson site
