## **Dam Inspection Report**

### **Pefferlaw Dam**

**D.M. Wills Project Number 19-5381**

**Prepared for:  
Lake Simcoe Region  
Conservation Authority**

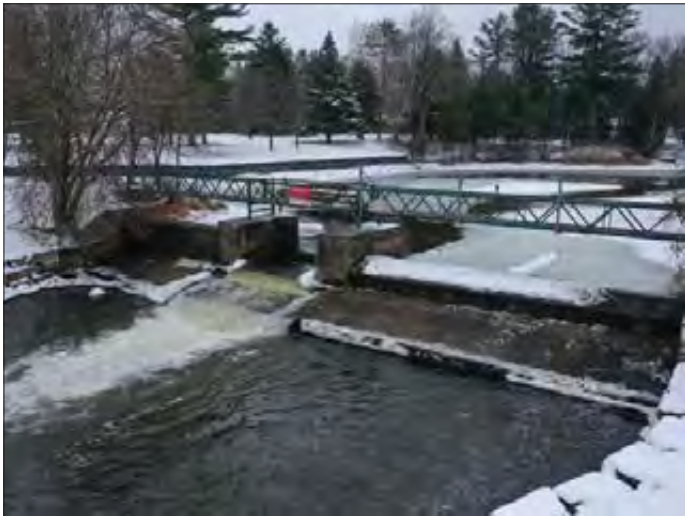
Photo 0921 - Nov. 19, 2019  
Pefferlaw Dam

Pefferlaw Dam, Downstream Elevation

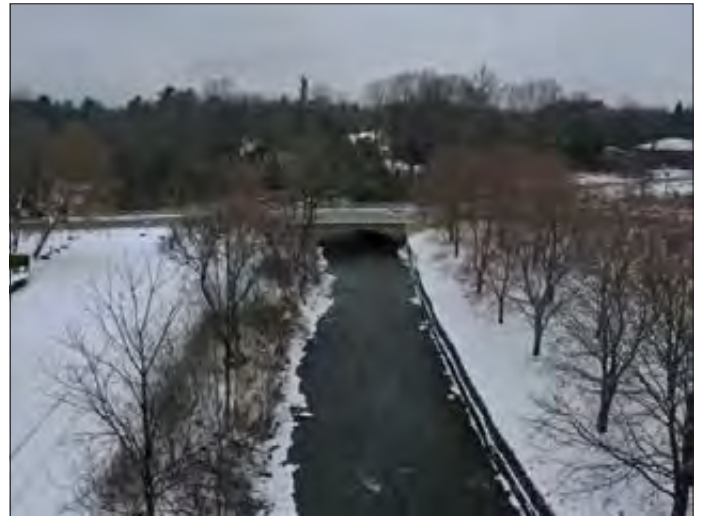
Photo 0925 - Nov. 19, 2019  
Pefferlaw Dam

Channel and Bridge Downstream of Dam

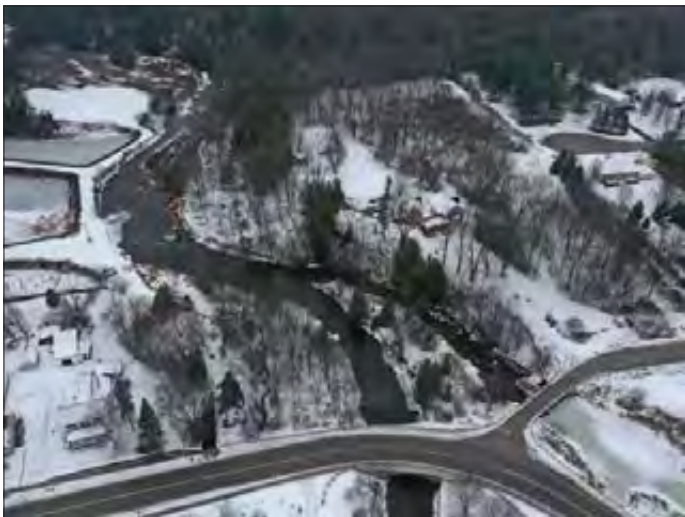
Photo 0927 - Nov. 19, 2019  
Pefferlaw Dam

Downstream Area

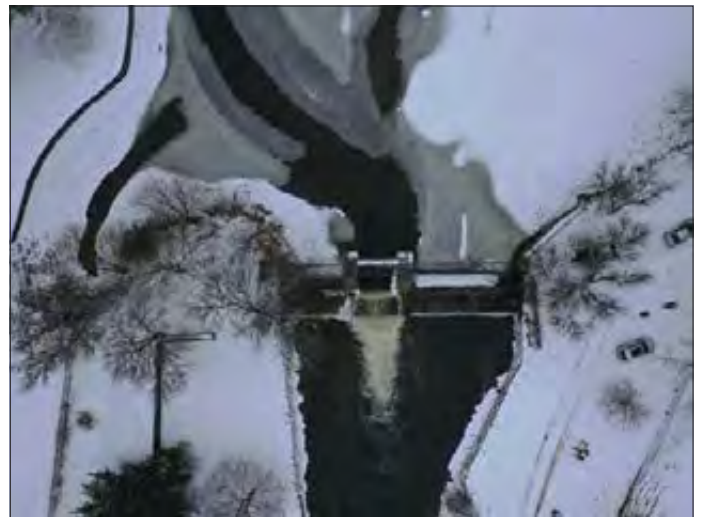
Photo 0934 - Nov. 19, 2019  
Pefferlaw Dam

General Plan View of Dam

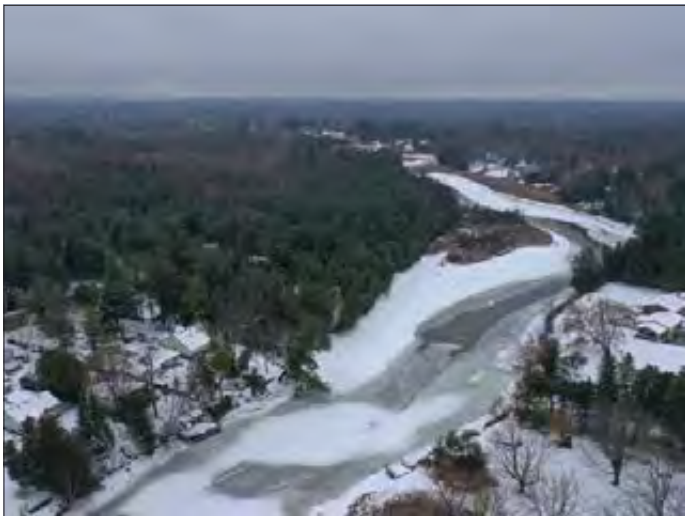
Photo 0935 - Nov. 19, 2019  
Pefferlaw Dam

Upstream Area / Head Pond

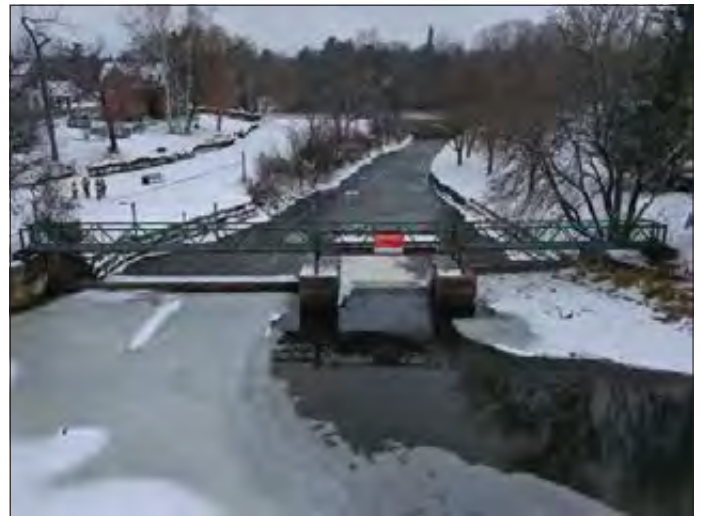
Photo 0939 - Nov. 19, 2019  
Pefferlaw Dam

Pefferlaw Dam, Upstream Elevation

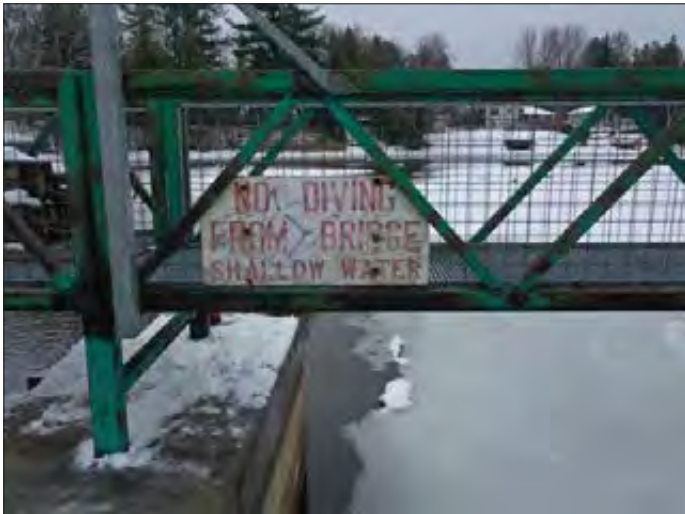
Photo 0922 - Nov. 19, 2019  
Pefferlaw Dam

Public Safety Sign, Downstream Side of Dam

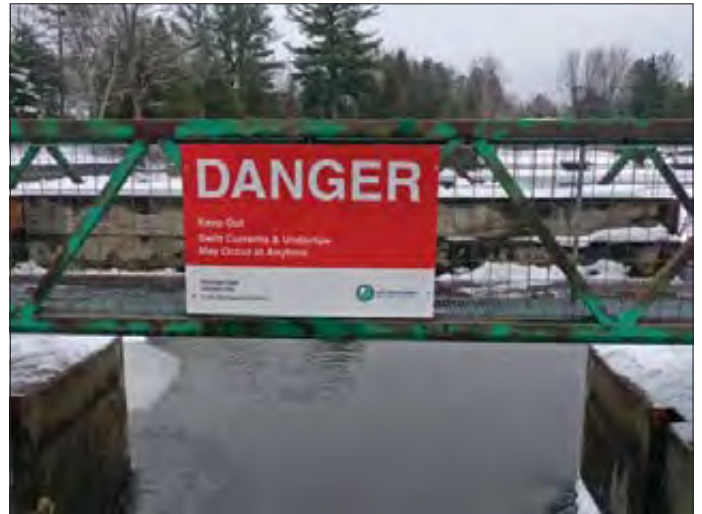
Photo 0923 - Nov. 19, 2019  
Pefferlaw Dam

Public Safety Sign, Downstream Side of Dam

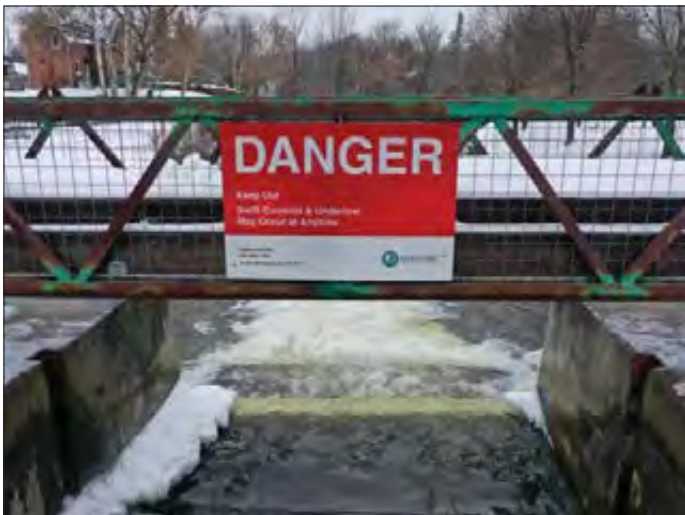
Photo 0940 - Nov. 19, 2019  
Pefferlaw Dam

Public Safety Sign, Upstream Side of Dam

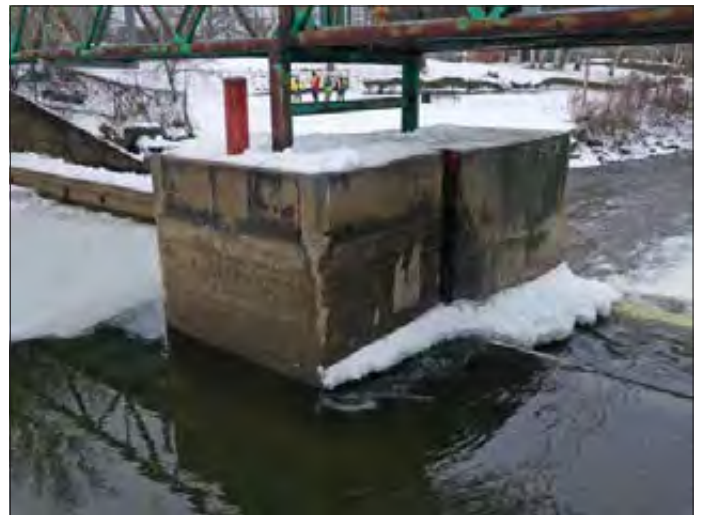
Photo 0942 - Nov. 19, 2019  
Pefferlaw Dam

Pier 1 (West Pier) Upstream and Right Face

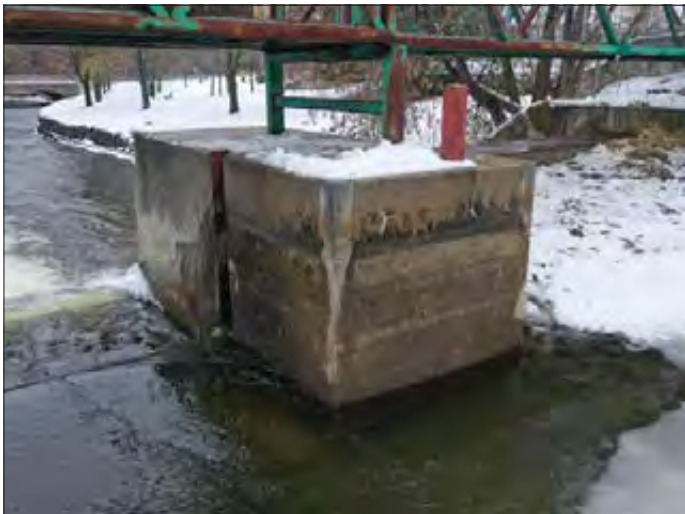
Photo 0943 - Nov. 19, 2019  
Pefferlaw Dam

Pier 2 (East Pier) Upstream and Left Face

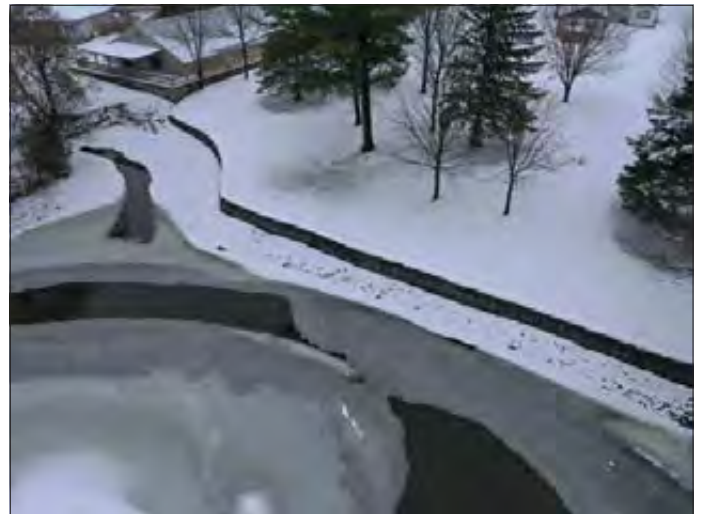
Photo 0947 - Nov. 19, 2019  
Pefferlaw Dam

Retaining Wall Along Head Pond Shoreline

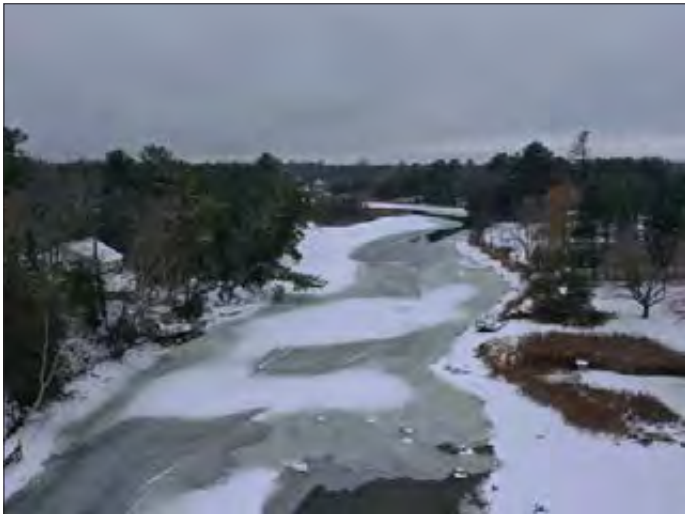
Photo 0948 - Nov. 19, 2019  
Pefferlaw Dam  
Head Pond

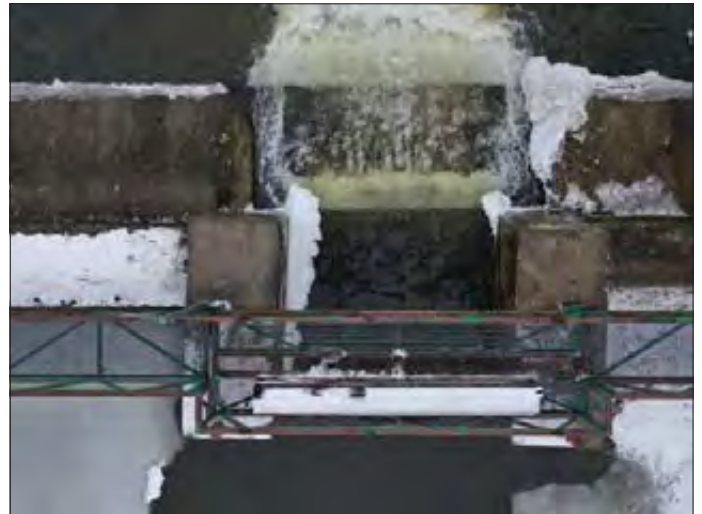
Photo 0961 - Nov. 19, 2019  
Pefferlaw Dam  
Sluiceway and Operating Deck from Above

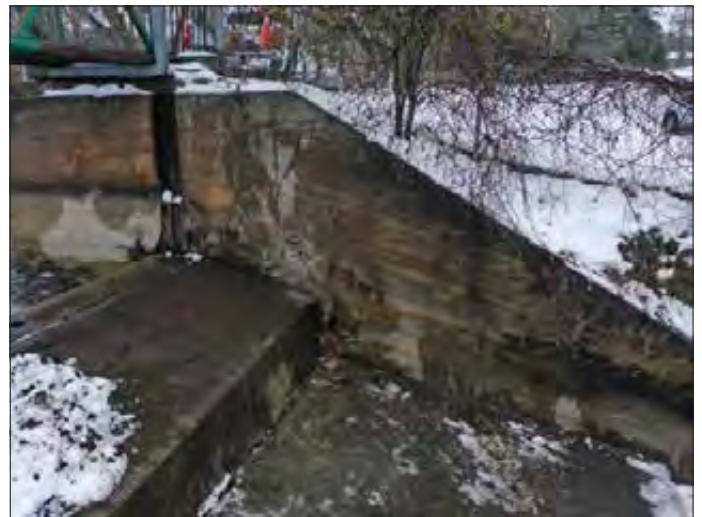
Photo 0965 - Nov. 19, 2019  
Pefferlaw Dam  
Left (West) Dam Abutment

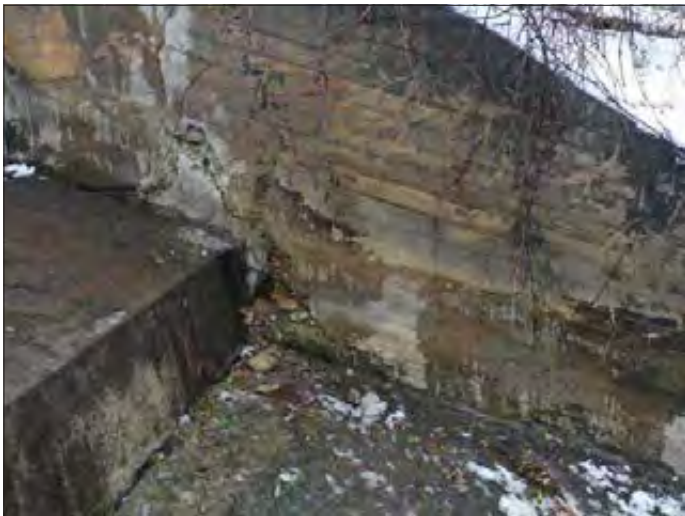
Photo 0966 - Nov. 19, 2019  
Pefferlaw Dam  
Left (West) Dam Abutment

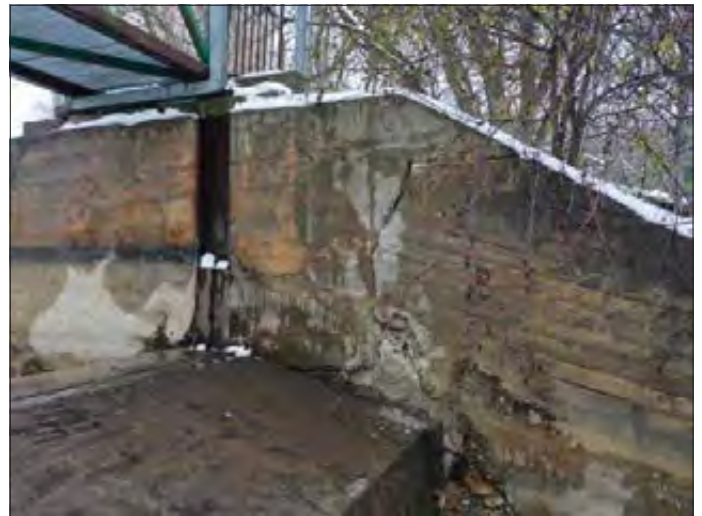
Photo 0967 - Nov. 19, 2019  
Pefferlaw Dam  
Left (West) Dam Abutment

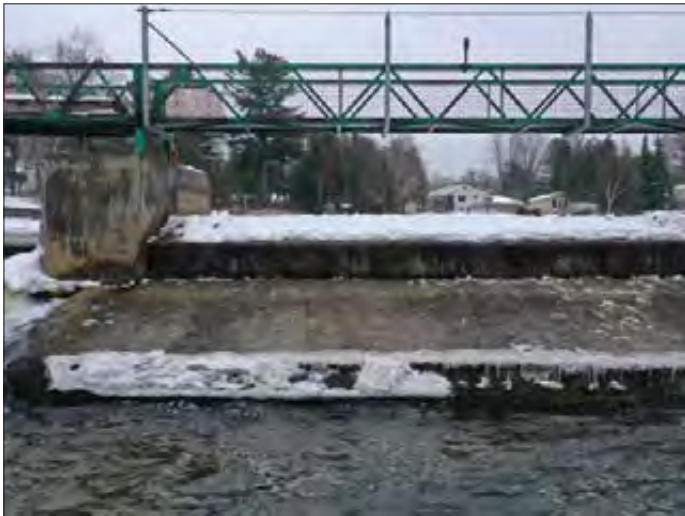
Photo 0968 - Nov. 19, 2019  
Pefferlaw Dam

Left (West) Apron and Weir

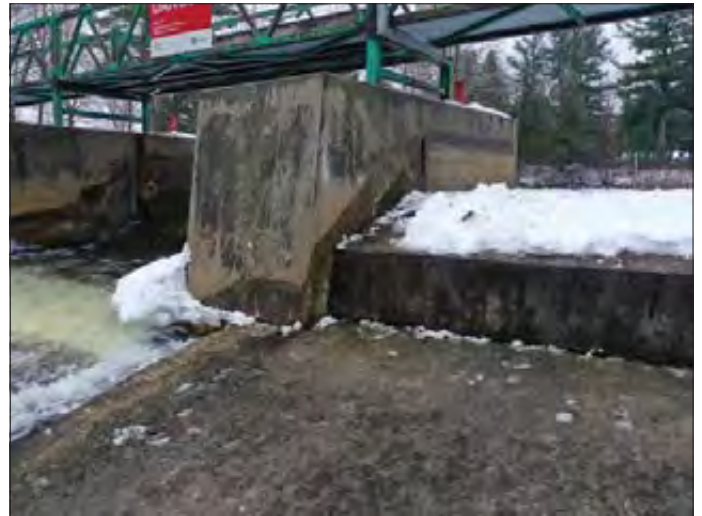
Photo 0969 - Nov. 19, 2019  
Pefferlaw Dam

Pier 1 (West Pier) Downstream and Left Sides

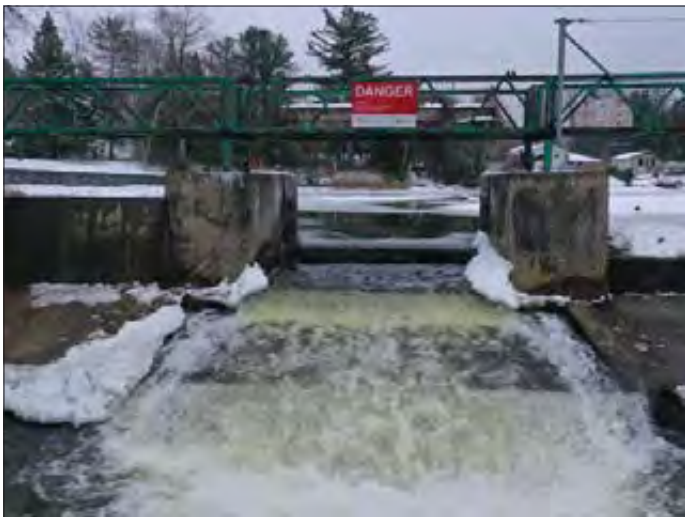
Photo 0972 - Nov. 19, 2019  
Pefferlaw Dam

Sluiceway Elevation

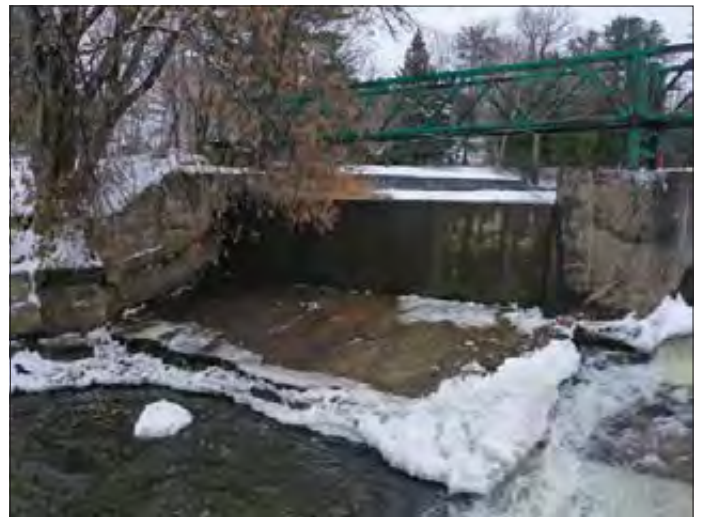
Photo 0973 - Nov. 19, 2019  
Pefferlaw Dam

Right (East) Weir, Apron and Dam Abutment

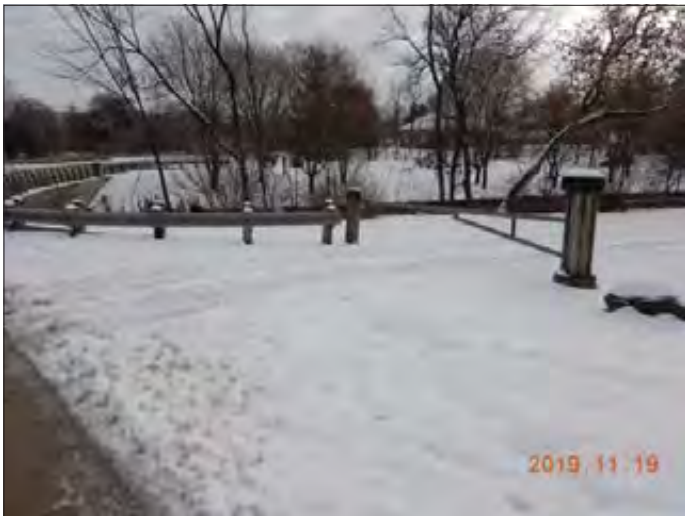
Photo 2607 - Sept 19, 2019  
Pefferlaw Dam

West Entrance and Gate

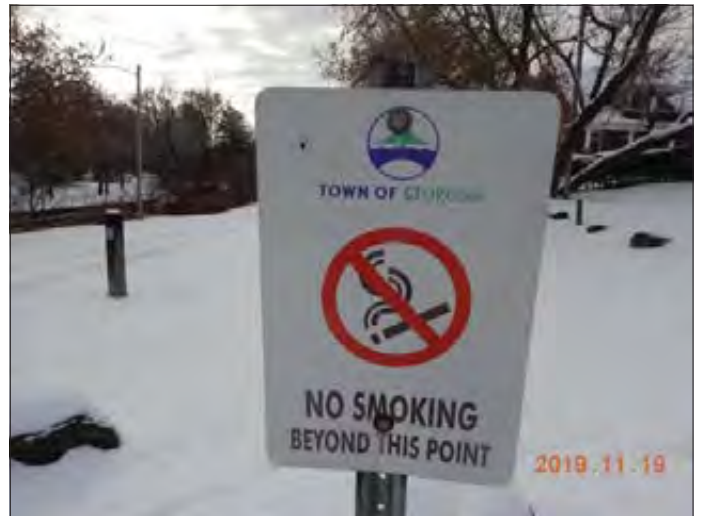
Photo 2608 - Sept 19, 2019  
Pefferlaw Dam

Sign Near West Entrance

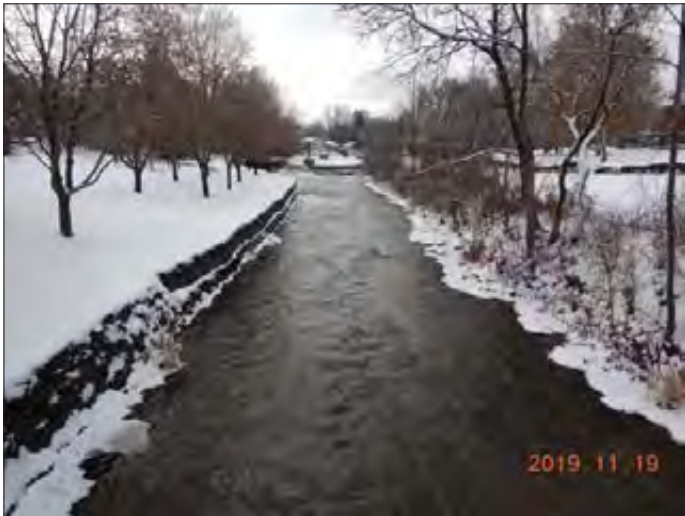
Photo 2612 - Sept 19, 2019  
Pefferlaw Dam

Looking Upstream from Pefferlaw Road Towards Dam

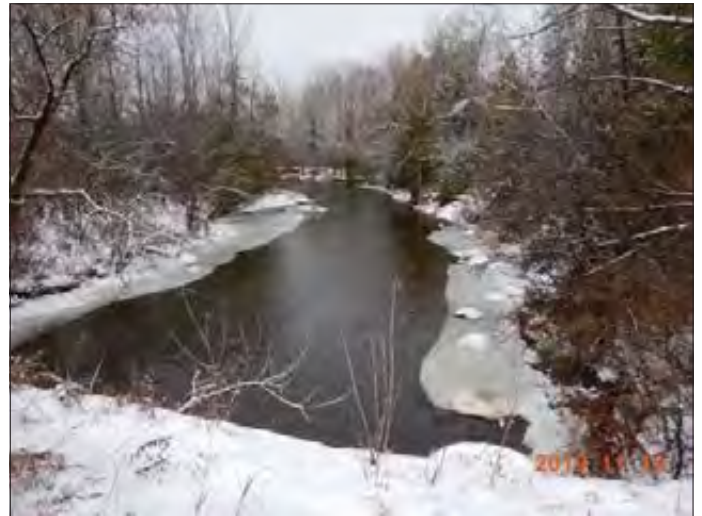
Photo 2614 - Sept 19, 2019  
Pefferlaw Dam

Downstream of Pefferlaw Road

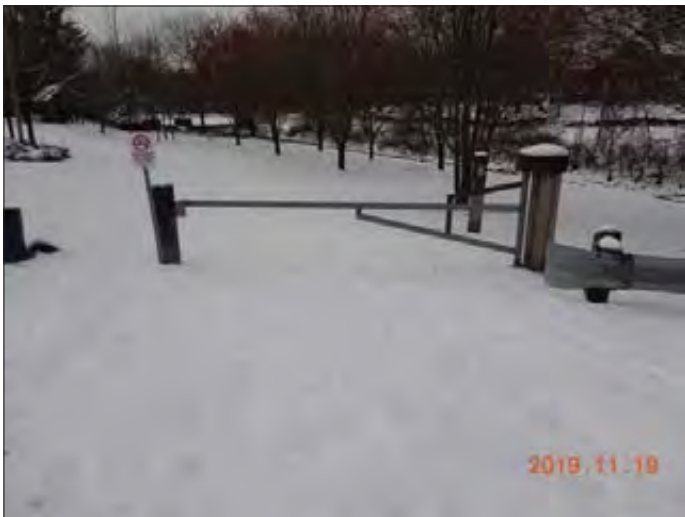
Photo 2629 - Sept 19, 2019  
Pefferlaw Dam

East Access and Gate

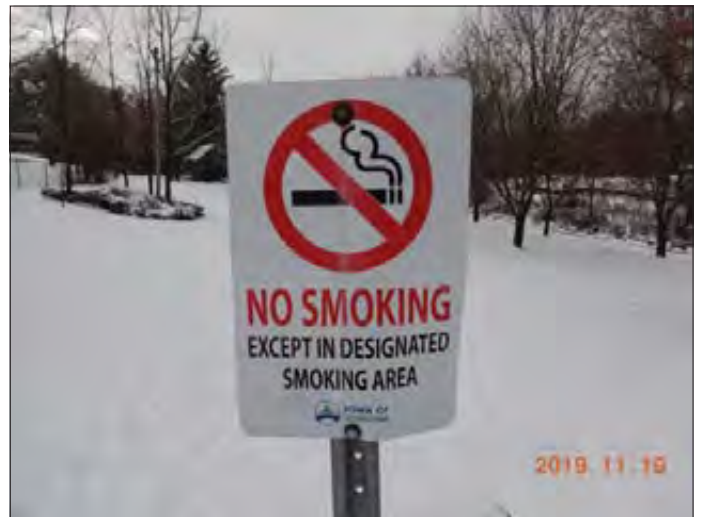
Photo 2631 - Sept 19, 2019  
Pefferlaw Dam

Sign near East Access

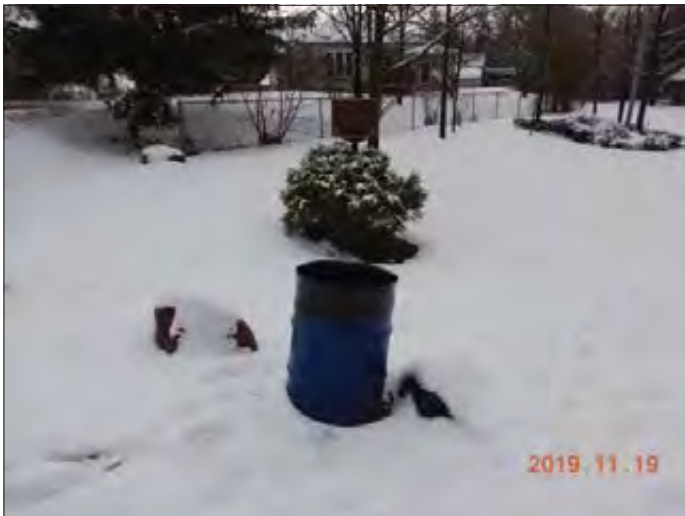
Photo 2632 - Sept 19, 2019  
Pefferlaw Dam

Garbage Receptacle Near East Access

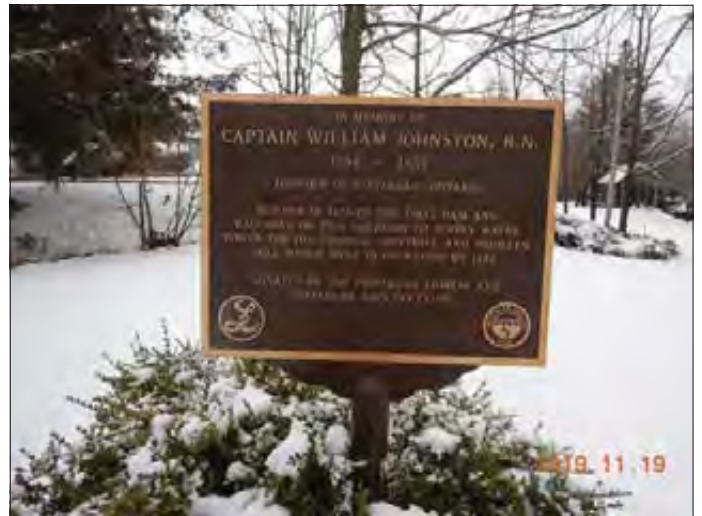
Photo 2633 - Sept 19, 2019  
Pefferlaw Dam

Commemorative Plaque Near East Gate

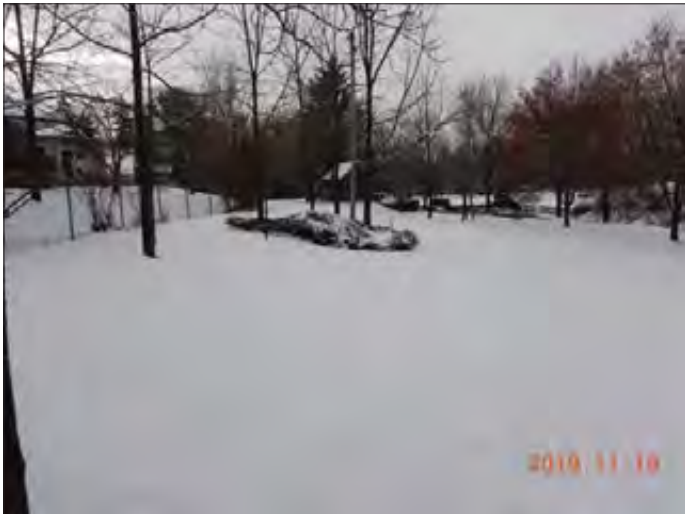
Photo 2637 - Sept 19, 2019  
Pefferlaw Dam

Park on East Side of Pefferlaw Brook

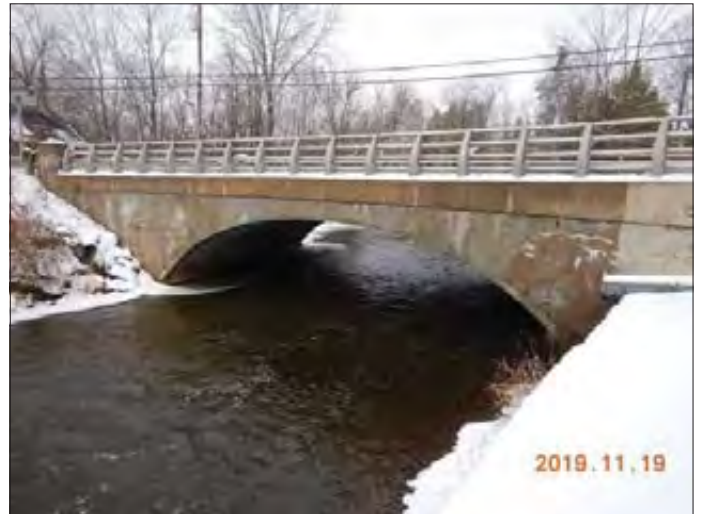
Photo 2638 - Sept 19, 2019  
Pefferlaw Dam

Pefferlaw Road Bridge

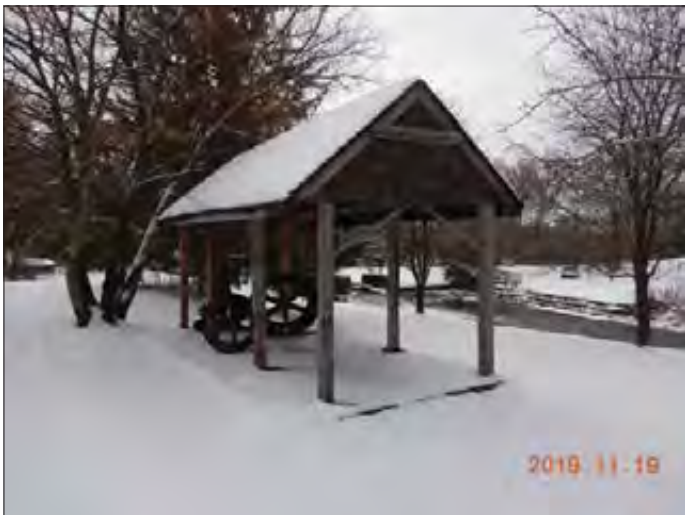
Photo 2645 - Sept 19, 2019  
Pefferlaw Dam

Park Structure

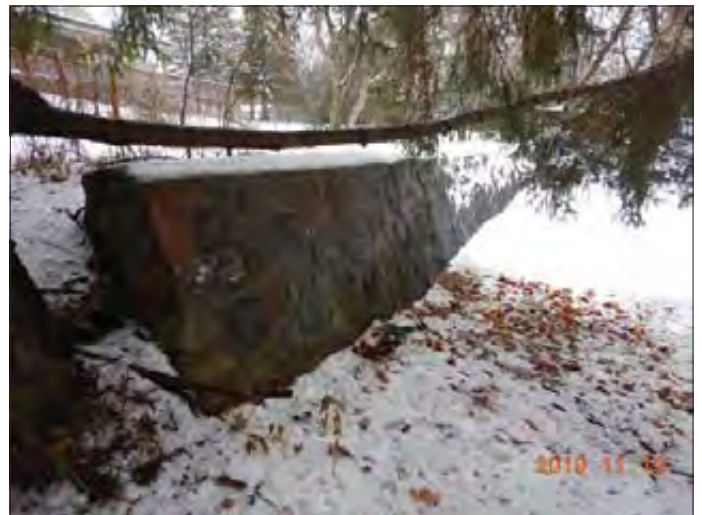
Photo 2648 - Sept 19, 2019  
Pefferlaw Dam

Masonry Wall from Former Mill Structure

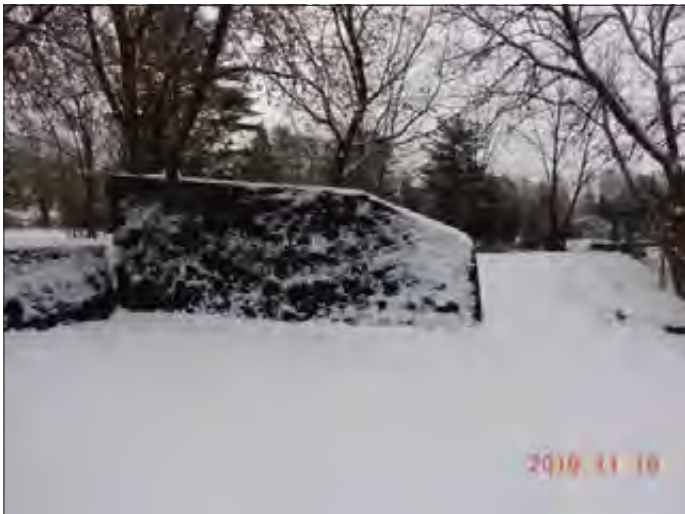
Photo 2655 - Sept 19, 2019  
Pefferlaw Dam

Masonry Wall from Former Mill Structure

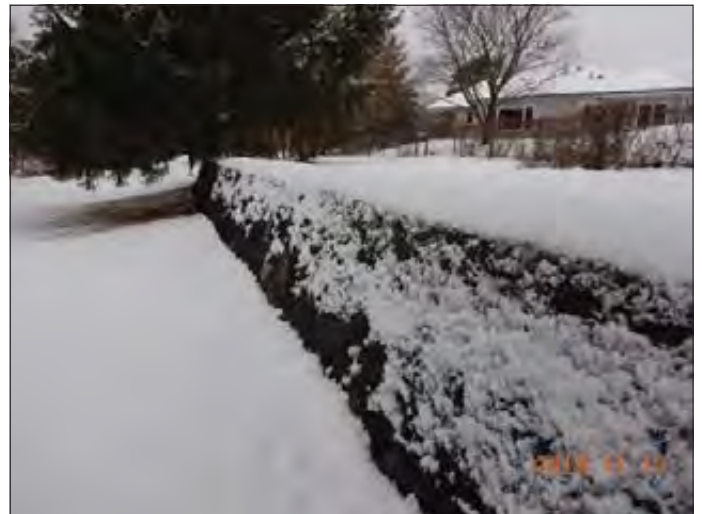
Photo 2657 - Sept 19, 2019  
Pefferlaw Dam

Masonry Wall from Former Mill Structure

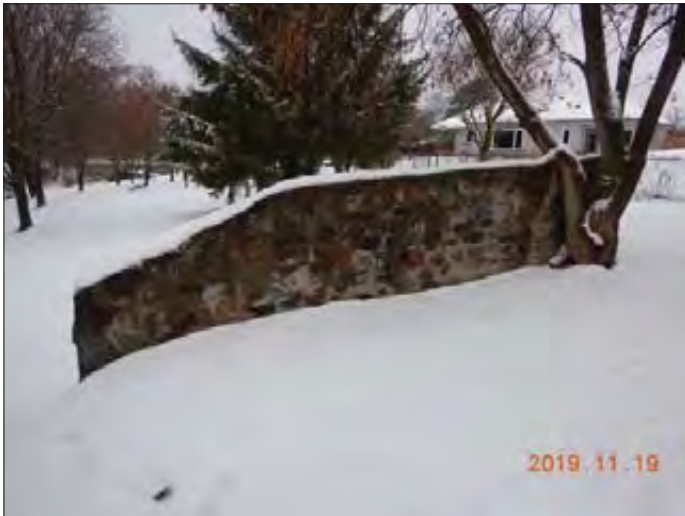
Photo 2658 - Sept 19, 2019  
Pefferlaw Dam

Masonry Wall of Former Mill Structure

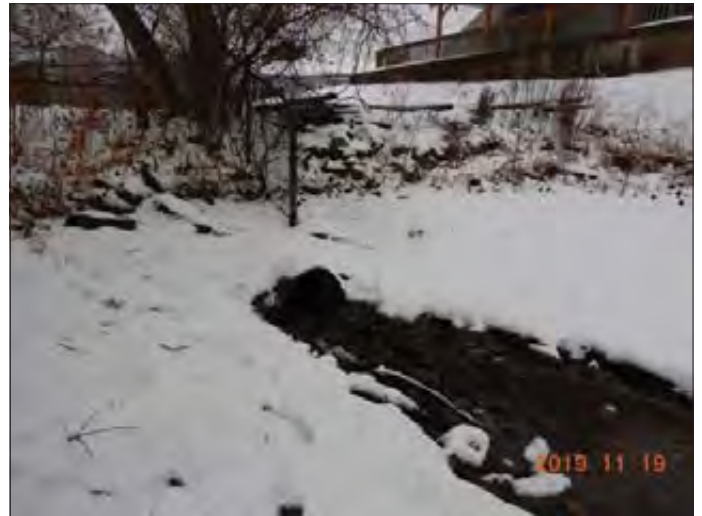
Photo 2659 - Sept 19, 2019  
Pefferlaw Dam

Culvert Inlet/Outlet East of Dam

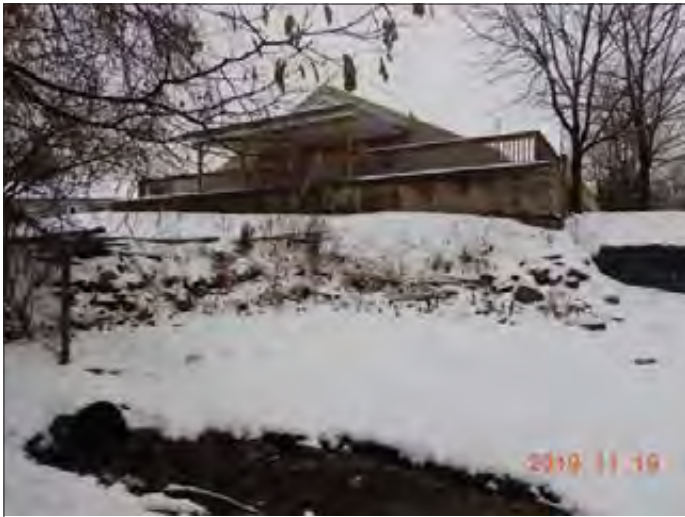
Photo 2660 - Sept 19, 2019  
Pefferlaw Dam

Expected Site of Former Mill Intake, East of Dam

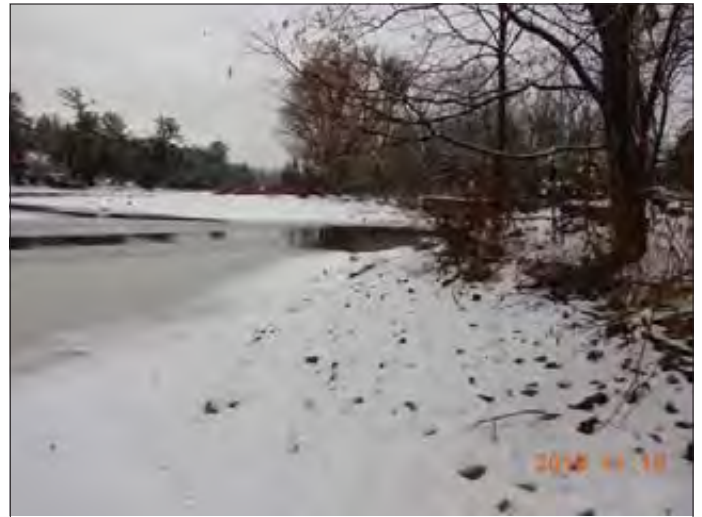
Photo 2665 - Sept 19, 2019  
Pefferlaw Dam

Upstream Right Earth Embankment

6. Repair the erosion on the upstream left (west) and right (east) sides of the earth embankment.	There is erosion at the normal operating water level.	Medium	\$25,000	The cost estimate assumes that the LSRCA will retain a contractor to complete grading and rip-rap placement along the shoreline.

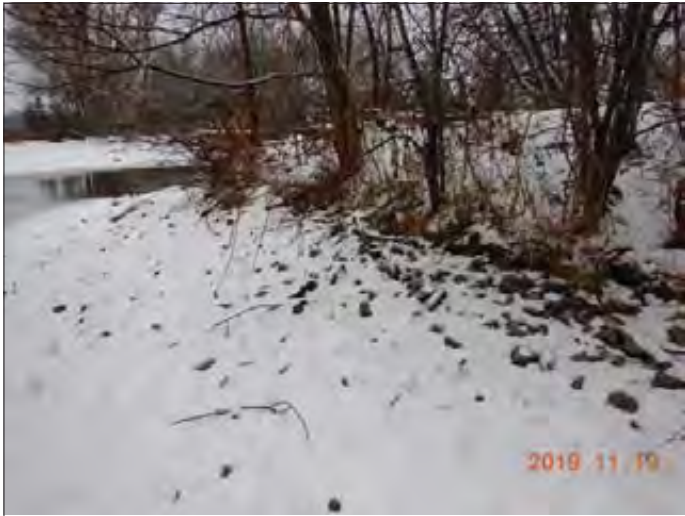
Photo 2666 - Sept 19, 2019  
Pefferlaw Dam

Upstream Right Earth Embankment

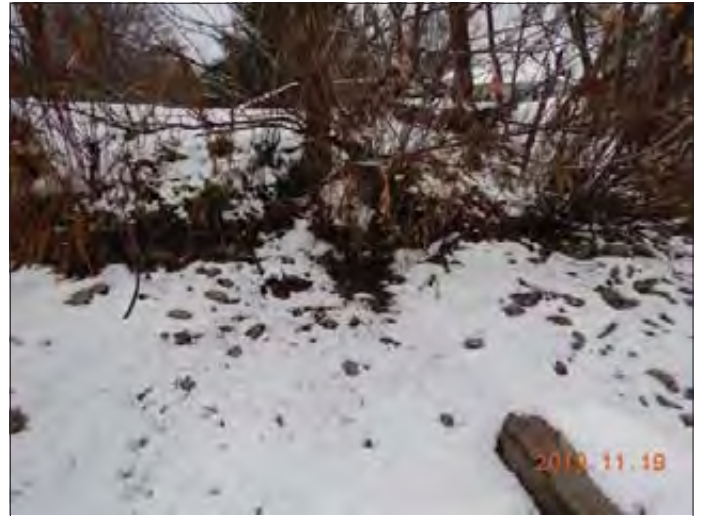
Photo 2667 - Sept 19, 2019  
Pefferlaw Dam

Upstream Right Earth Embankment

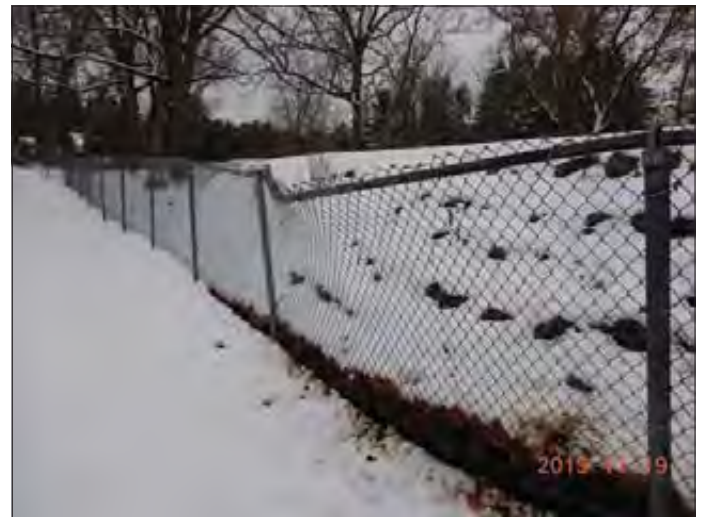
Photo 2694 - Sept 19, 2019  
Pefferlaw Dam  
Fencing on West Side of Park

4. Repair the chain link fence along the west property line.	The chain link fence is broken.	Low	\$5,000	The cost estimate assumes that the LSRCA would retain a contractor to complete this work. Cost savings may be realized if the LSRCA is able to complete this work using internal resources.

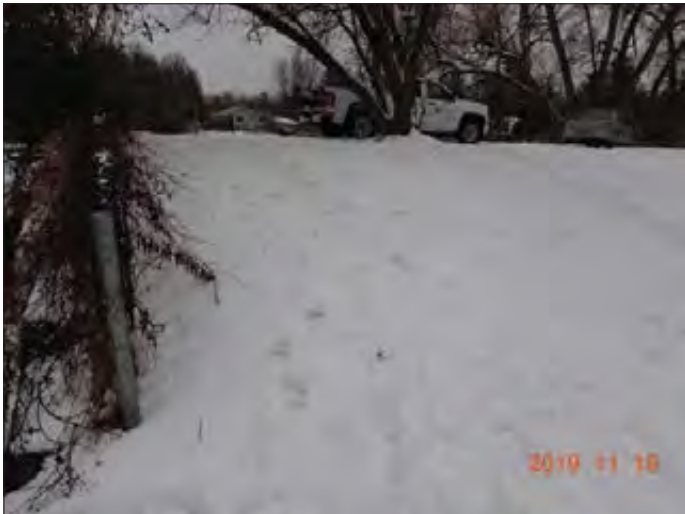
Photo 2703 - Sept 19, 2019  
Pefferlaw Dam

Downstream Left (West) Earth Embankment

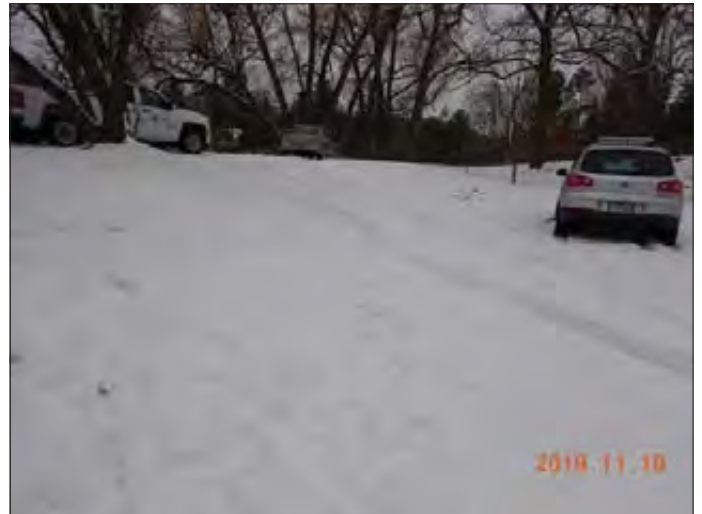
Photo 2704 - Sept 19, 2019  
Pefferlaw Dam

Downstream Left (West) Earth Embankment

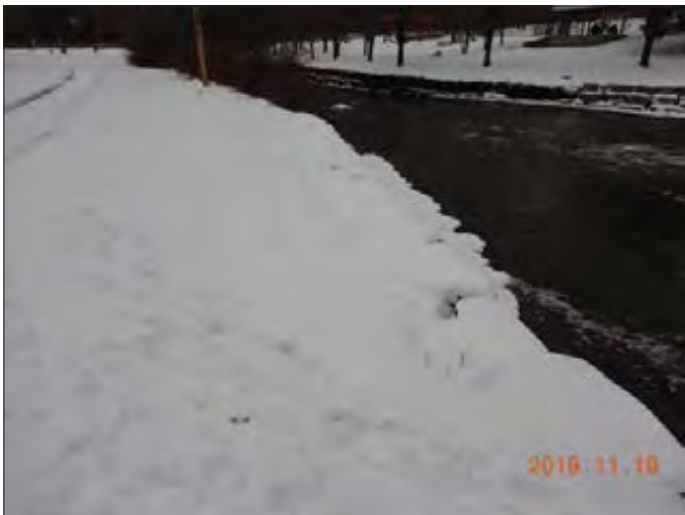
Photo 2705 - Sept 19, 2019  
Pefferlaw Dam

Downstream Left (West) Armour Stone Retaining Wall

7. Repair the erosion behind the downstream left (west) and right (east) armour stone retaining walls.	There is erosion behind the armour stone retaining walls.	High	\$25,000	The scope of the erosion repair is difficult to determine due to the presence of snow on the ground during the dam inspection. The cost estimate assumes that the LSRCA will retain a contractor to complete the work.

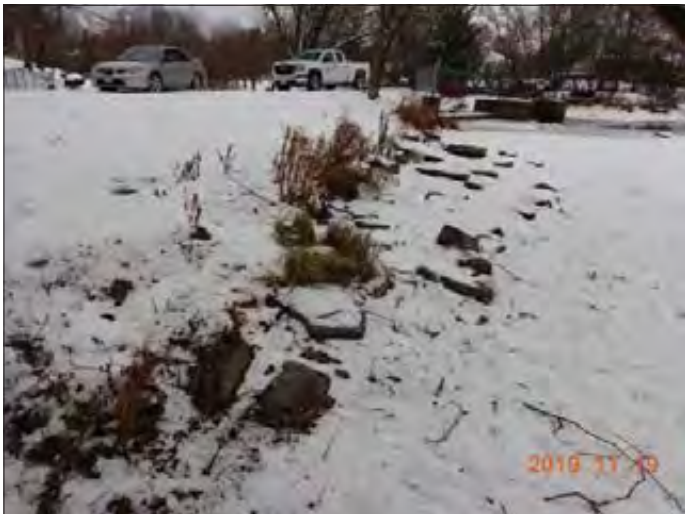
Photo 2712 - Sept 19, 2019  
Pefferlaw Dam

Upstream Left (West) Earth Embankment

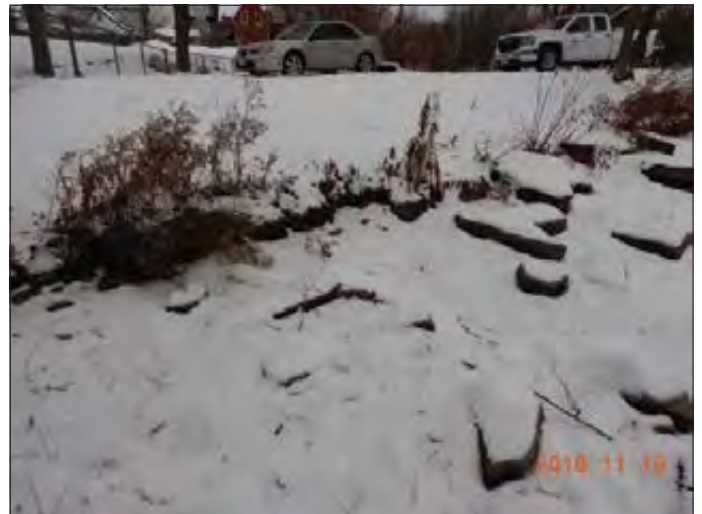
Photo 2713 - Sept 19, 2019  
Pefferlaw Dam

Upstream Left (West) Earth Embankment

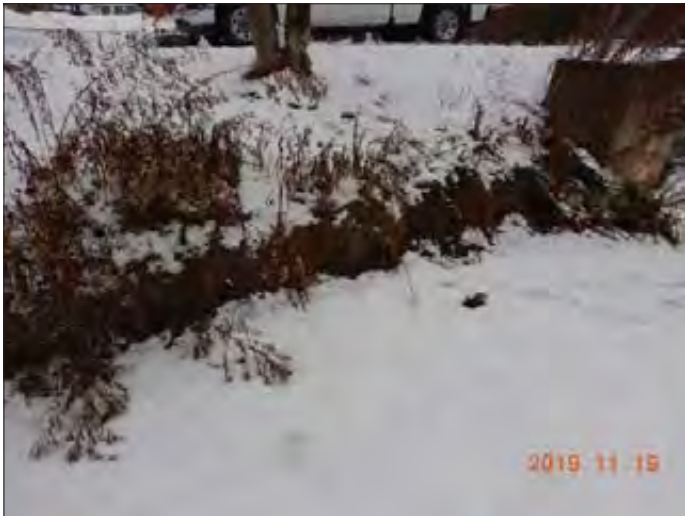
Photo 2715 - Sept 19, 2019  
Pefferlaw Dam

Upstream Left (West) Earth Embankment

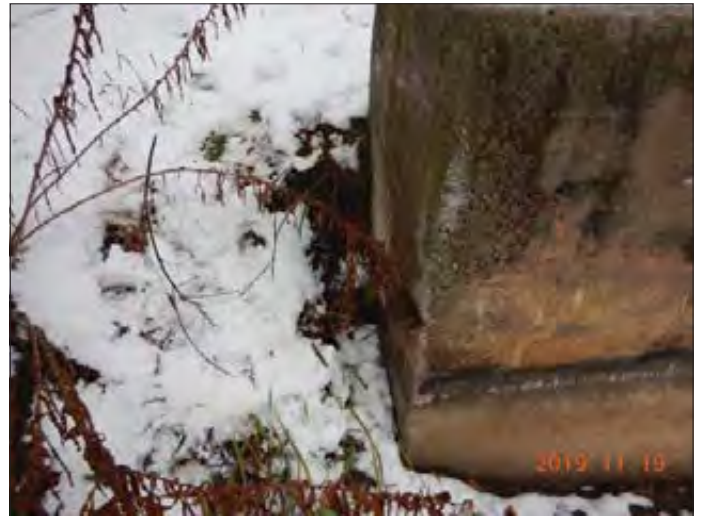
Photo 2717 - Sept 19, 2019  
Pefferlaw Dam

Upstream Left (West) Earth Embankment

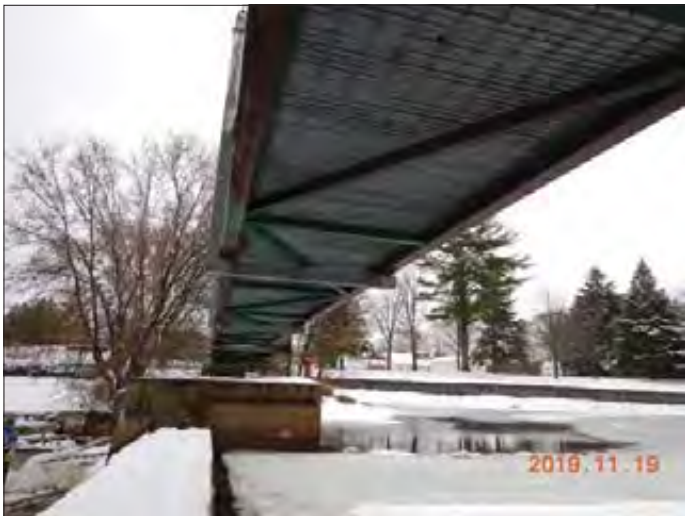
Photo 2731 - Sept 19, 2019  
Pefferlaw Dam

Underside of Truss Bridge

3. Undertake a structural evaluation of the truss bridge within one (1) year and develop a detailed repair or replacement design for the truss bridge and dam deck. Depending on the results of the structural evaluation, temporary repairs, the removal of the stoplogs stored on the deck or temporary suspension of dam operations may be required.	The steel truss is in poor condition with failure of the coating and cracking and bowing of the structural steel members.	Immediate	\$5,000*	The cost estimate provided is the cost for the structural evaluation only. The cost for the detailed design for the repair or replacement will depend on the results of the structural evaluation and on the structure type but would likely be in the range of \$30,000 to \$60,000.  This work should be completed by a professional consulting engineer.  As an alternate to undertaking Recommendation 3, the LSRCA could stop operating the dam, remove the stoplogs stored on the dam and eliminate public access across the dam. However, this is only seen as a short term solution and a permanent solution, such as repair, replacement or dam decommissioning will ultimately be required in order to ensure public and operator safety.

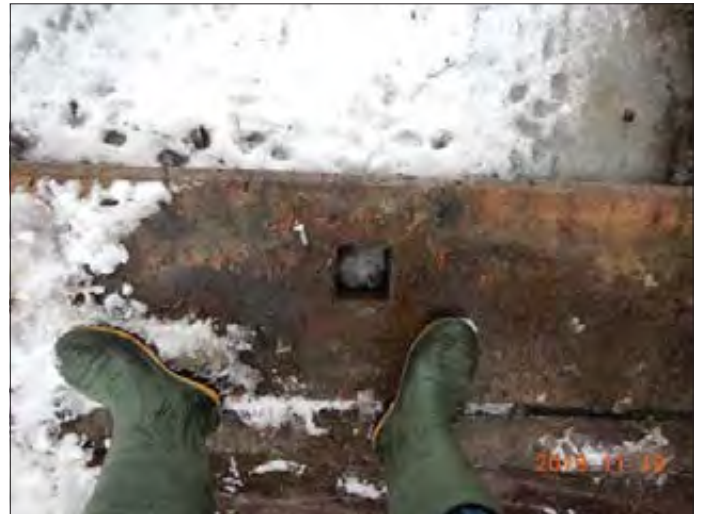
Photo 2735 - Sept 19, 2019  
Pefferlaw Dam

Flashboard Post Hole (Typical)

Recommendation	Description of Deficiency	Priority	Estimated Cost	Additional Comments
5. Replace the flashboards and flashboard posts, as planned. Note: Future replacement of the stoplogs may be required.	The flashboards and flashboard posts are in poor condition and the LSRCA is already planning to replace them. The stoplogs may require replacement in 2 to 5 years.	High	\$8,000	The cost estimate assumes that the LSRCA will outsource the fabrication of the flashboard posts and will fabricate the flashboards using internal resources.

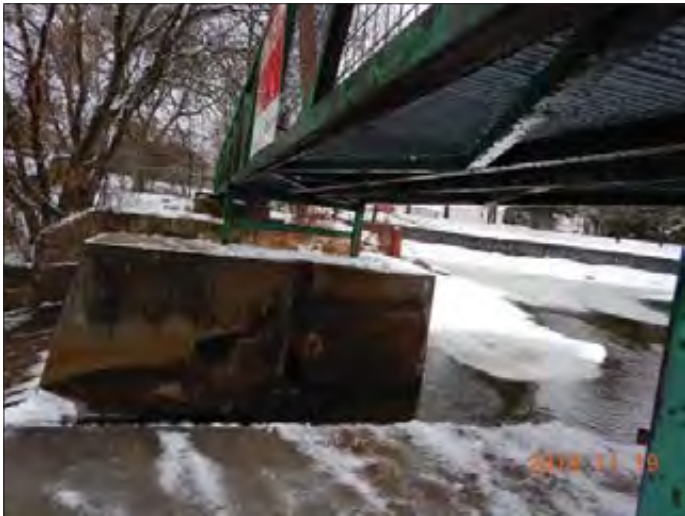
Photo 2744 - Sept 19, 2019  
Pefferlaw Dam

Left (West) Side of Pier 2 (East Pier)

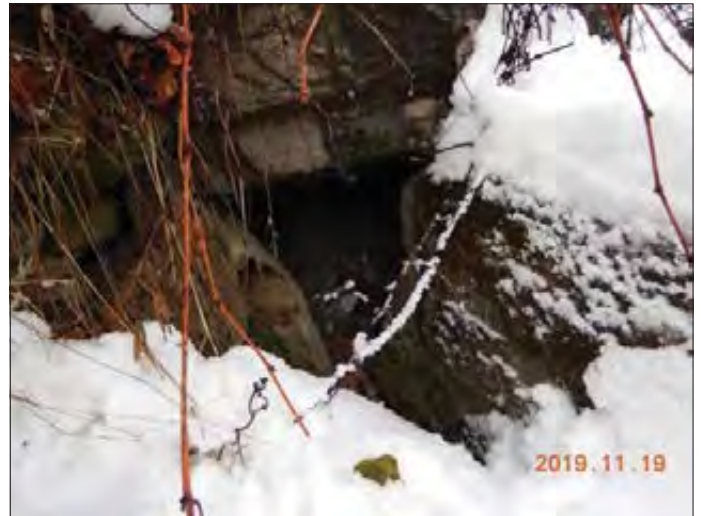
Photo 2771 - Sept 19, 2019  
Pefferlaw Dam  
Void Below Armour Stone Wall, Left (West) Side

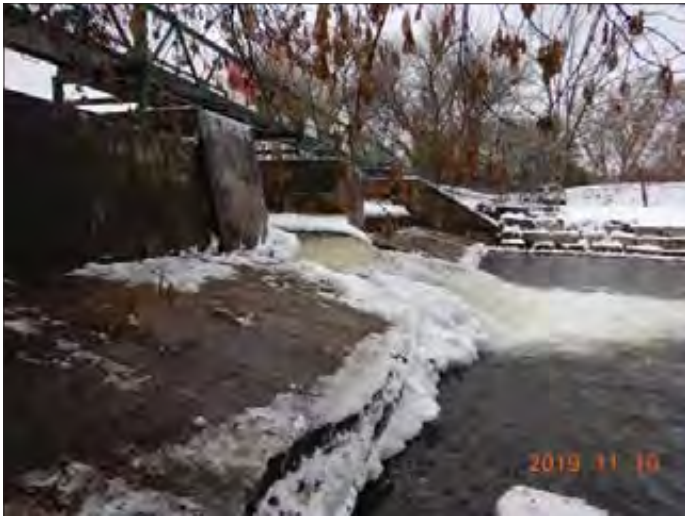
Photo 2829 - Sept 19, 2019  
Pefferlaw Dam

Downstream Side of Dam from Right (East) Side

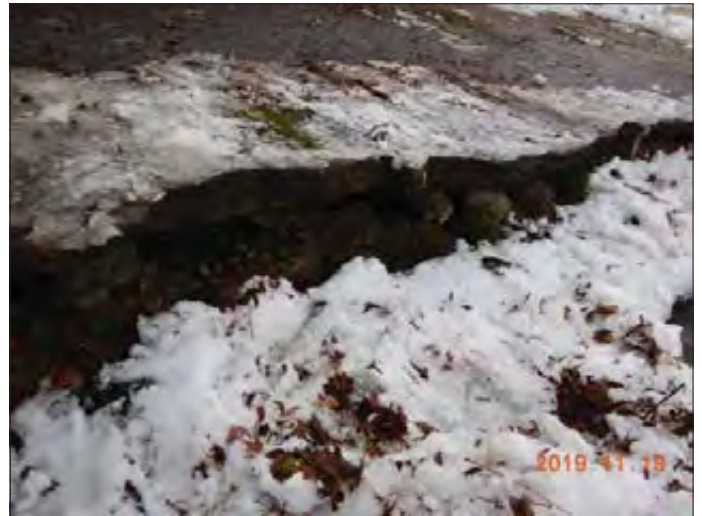
Photo 2832 - Sept 19, 2019  
Pefferlaw Dam

Right (East) Apron

**Right (East) Apron** – There are some medium width cracks along the apron surface. The apron is undermined by approximately 1500 mm and it would appear as though the end of the apron has spalled off. Video from the underwater inspection appears to indicate that the undermining is restricted to the right side of the apron and does not extend to the sluiceway. The top of the apron is approximately 700 mm off the river bottom.

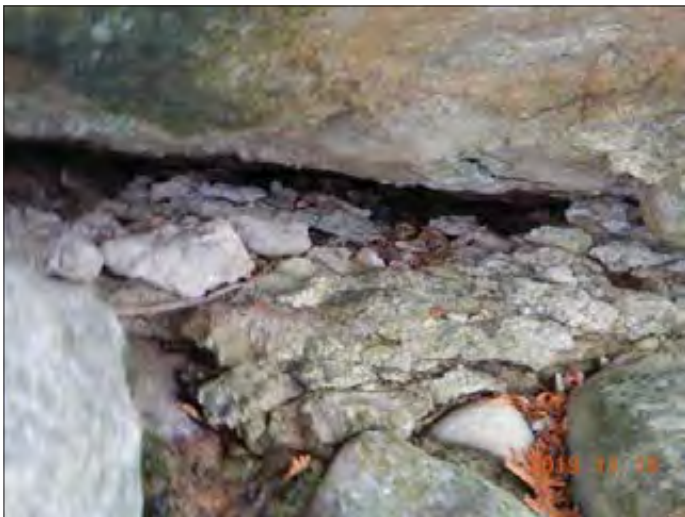
Photo 2851 - Sept 19, 2019  
Pefferlaw Dam

Undercutting in Right (East) Apron

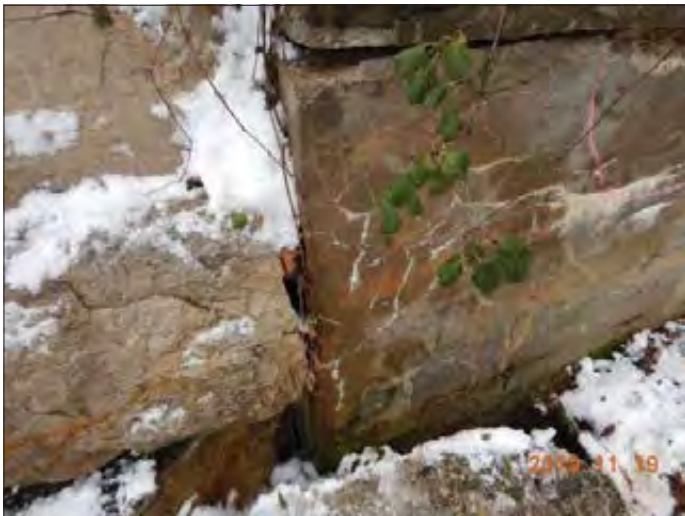
Photo 2834 - Sept 19, 2019  
Pefferlaw Dam

Right (East) Dam Abutment

**Right (East) Dam Abutment** – The right (east) abutment is in poor to very poor condition. There is evidence of patch repairs at this wall area. The majority of the wall surface is delaminated and there are several large spalls. There is some map cracking with efflorescence at the far downstream end of the wall, with a 300 mm by 1000 mm by 300 mm deep void. There is a masonry wall perched on the downstream edge of the right (east) abutment that is in very poor condition.

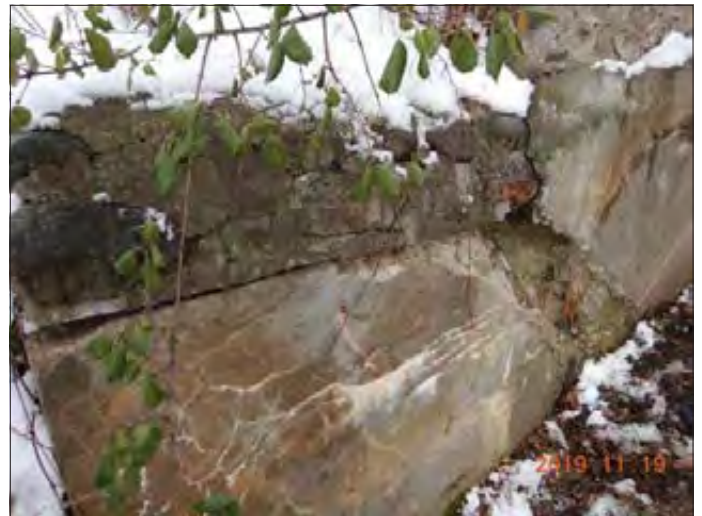
Photo 2835 - Sept 19, 2019  
Pefferlaw Dam

Right (East) Dam Abutment
