## **Dam Inspection Report**

### **Pefferlaw Dam**

**D.M. Wills Project Number 19-5381**

**Prepared for:  
Lake Simcoe Region  
Conservation Authority**

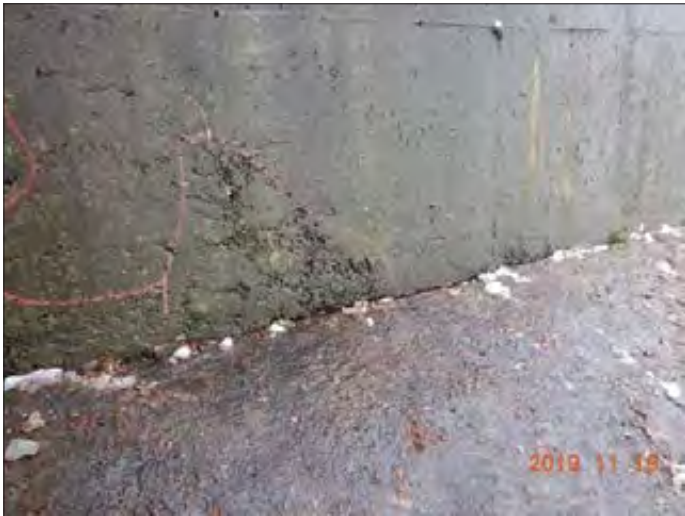
Photo 2843 - Sept 19, 2019  
Pefferlaw Dam

Downstream Side of Right (East) Weir

**Right (East) Weir** – The upstream face of the weir is generally in good condition with some bug holes. The weir crest is in good condition. The downstream face of the weir is in fair to good condition with honeycombing noted near the interface with the abutment (1.2 m<sup>2</sup>).

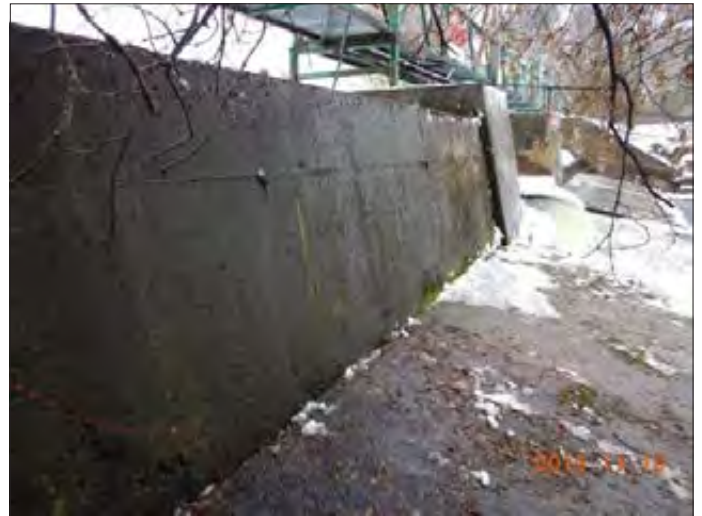
Photo 2844 - Sept 19, 2019  
Pefferlaw Dam

Downstream Side of Right (East) Weir

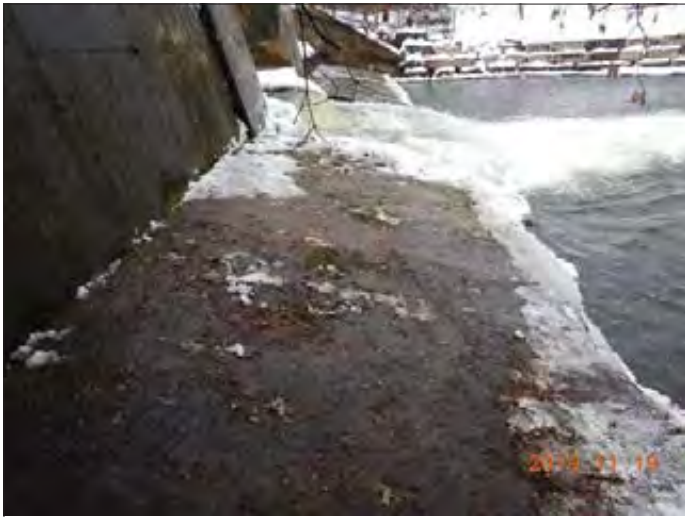
Photo 2845 - Sept 19, 2019  
Pefferlaw Dam

Right (East) Apron

**Right (East) Apron** – There are some medium width cracks along the apron surface. The apron is undermined by approximately 1500 mm and it would appear as though the end of the apron has spalled off. Video from the underwater inspection appears to indicate that the undermining is restricted to the right side of the apron and does not extend to the sluiceway. The top of the apron is approximately 700 mm off the river bottom.

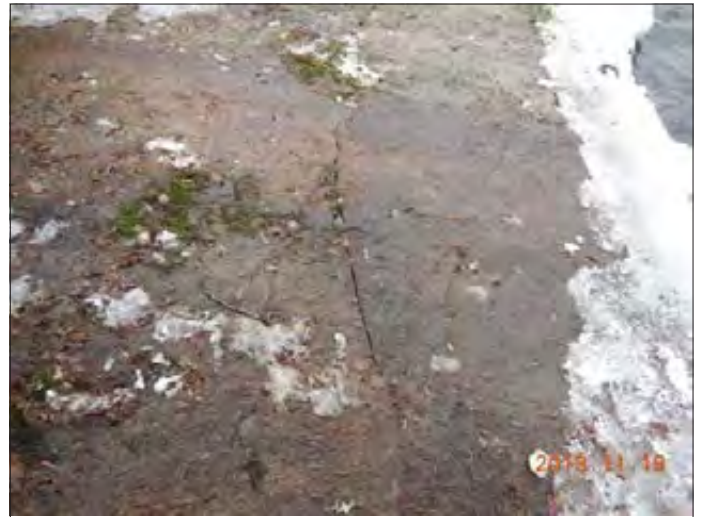
Photo 2846 - Sept 19, 2019  
Pefferlaw Dam

Right (East) Apron
